Reflective Cracking Construction Notes

Date: December 8, 2014

Project: Reflective Cracking Indoor Phase IV

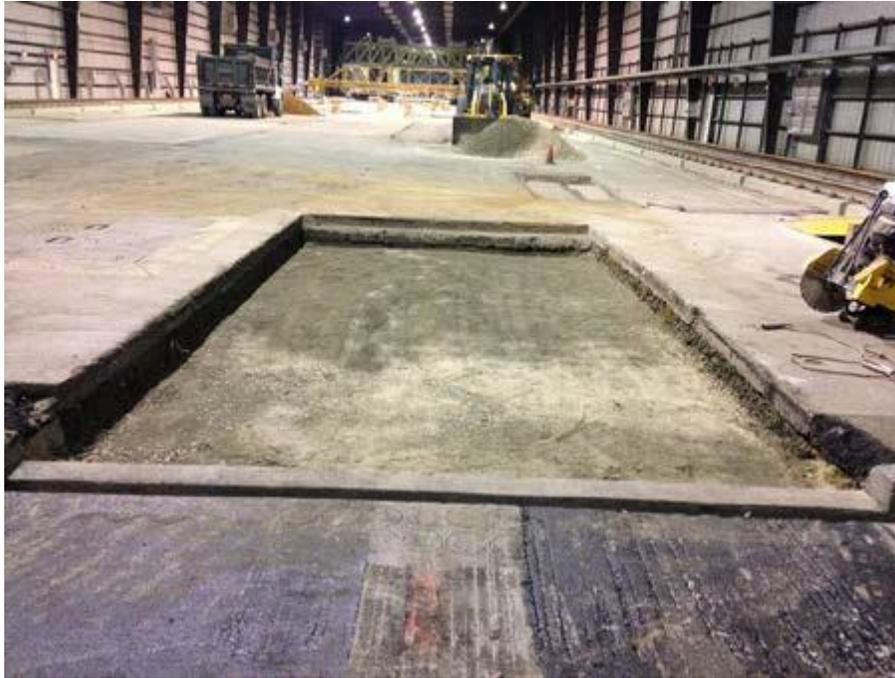
(a)

JBT excavated a portion of the existing high strength subgrade from beneath the proposed lead-in slab to the West end of the test rig. The excavated area was then backfilled with 12 inches of compacted P-209 to create a base layer for the support of the proposed slab, as shown in Figure 1. The finished surface of the P-209 layer was established at approximately 14 inches below the surrounding pavement surface in order to accommodate the placement of the 9-inch thick cement concrete slab and at least 5 inches of HMA (hot mix asphalt) test pavement. The excavated subgrade soil was stockpiled in the NAPTF for removal at a later date.

Figure 1. Compacted P-209 to Create a Base Layer for Support of the Proposed Slab.
