## Reflective Cracking Construction Notes

**Date:** December 10, 2014

**Project:** Reflective Cracking Indoor Phase IV

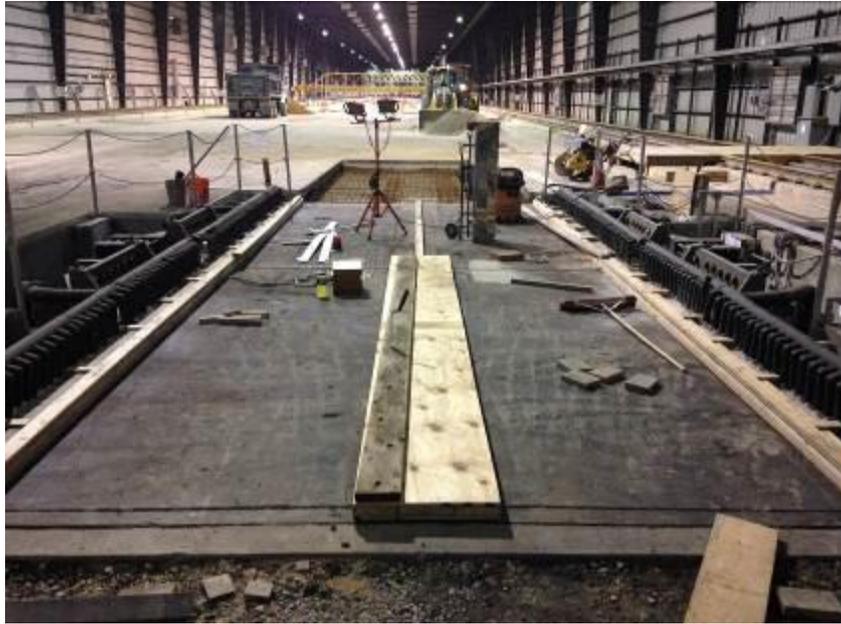
(a) Beginning of Formwork Installation.

Figure 1. Installation of the Formwork for the Phase IV Paving and Installation of Reinforcing Steel.

United Concrete personnel began the installation of the formwork for the Phase IV paving. They also installed the 6x6 WWF reinforcing steel, as shown below in Figure 1, (supported on chairs) within the excavation for the new lead-in slab to the West of the reflective cracking rig. That slab is planned to be poured later in the week.

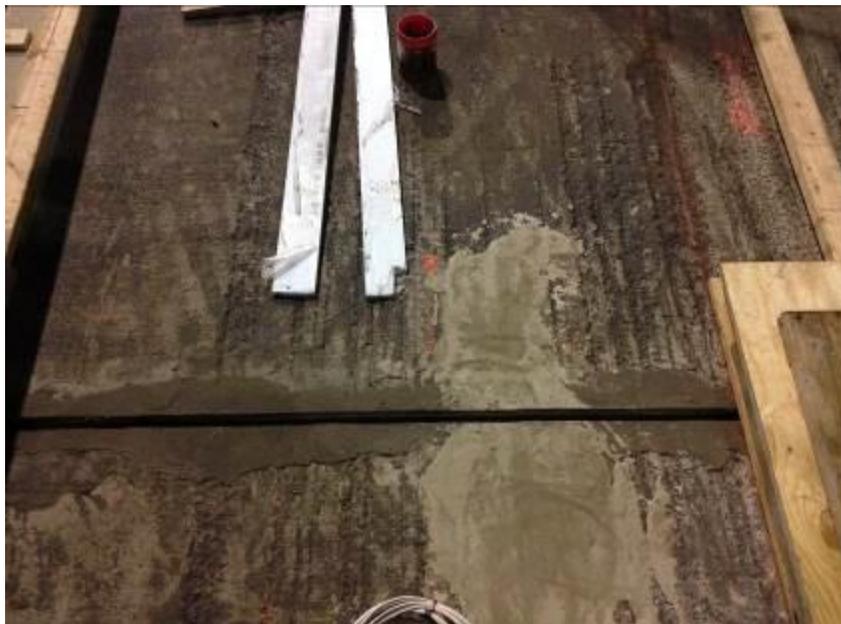
(b) Beginning of Formwork Installation (2).

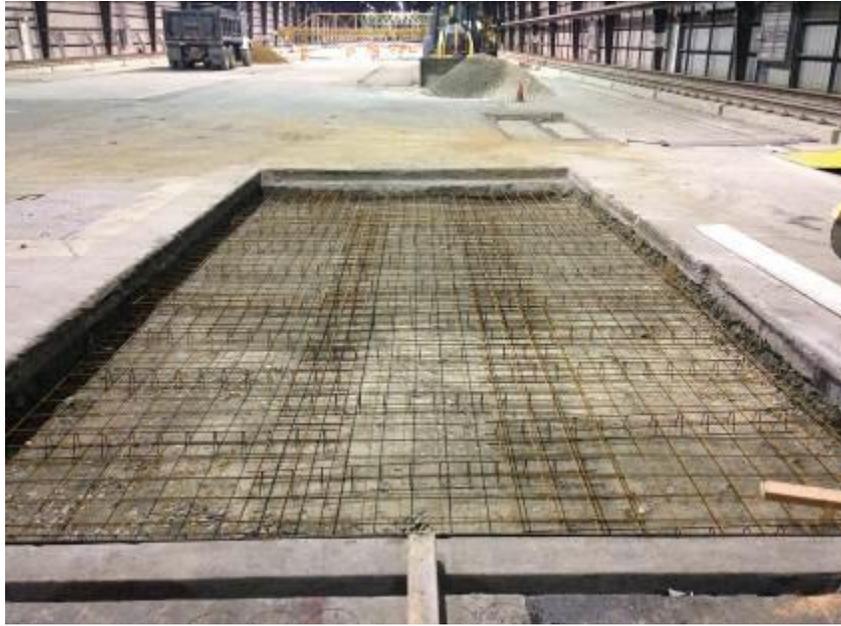
(c) Reinforcing Steel Installation.
