## Reflective Cracking Construction Notes

**Date:** December 17, 2014

**Project:** Reflective Cracking Indoor Phase IV

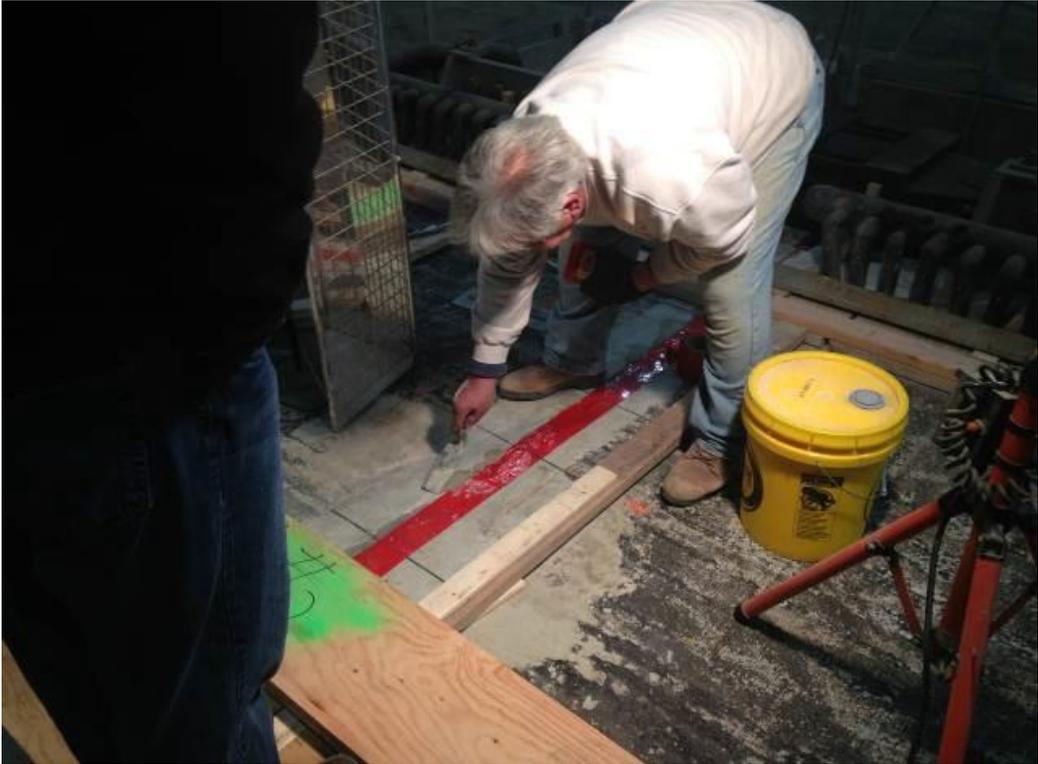
United also re-patched the surface of the test rig slabs along the edges of the joint using Rapid Set Cement All® repair cement, shown in Figure 1.

Figure 1. Patching of Test Rig Slab Joint Edge.

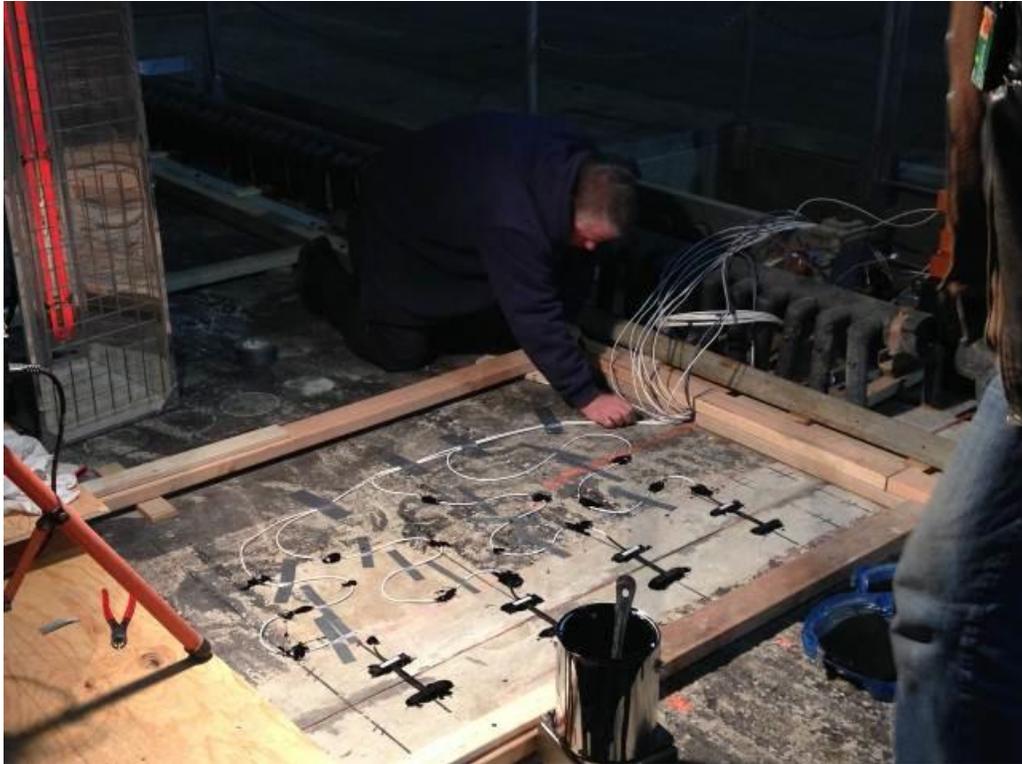
Subsequent to the completion of the formwork and edge patching, SRA and ARA personnel installed the Dynatest asphalt strain gauges (ASG’s) across the joint on concrete surface of the

test rig, shown in Figure 2. (4) ASGs were installed on each test item (8 total) by setting the anchor points of each gauge in a thin layer of asphalt binder prepared by the NAPTF laboratory. The binder was also used to secure the gauge lead wires to the concrete surface at numerous points. Please note that the (2) outer ASGs on each test item were set approximately 11 inches from the edges of the forms in an effort to locate these ASG's as closely as possible to the center of each track of the IR Blaw-Knox PF-545 pathway paver, where the stresses imparted by the tracks tend to be lowest.

Figure 2. Finalizing Instrumentation Installation.

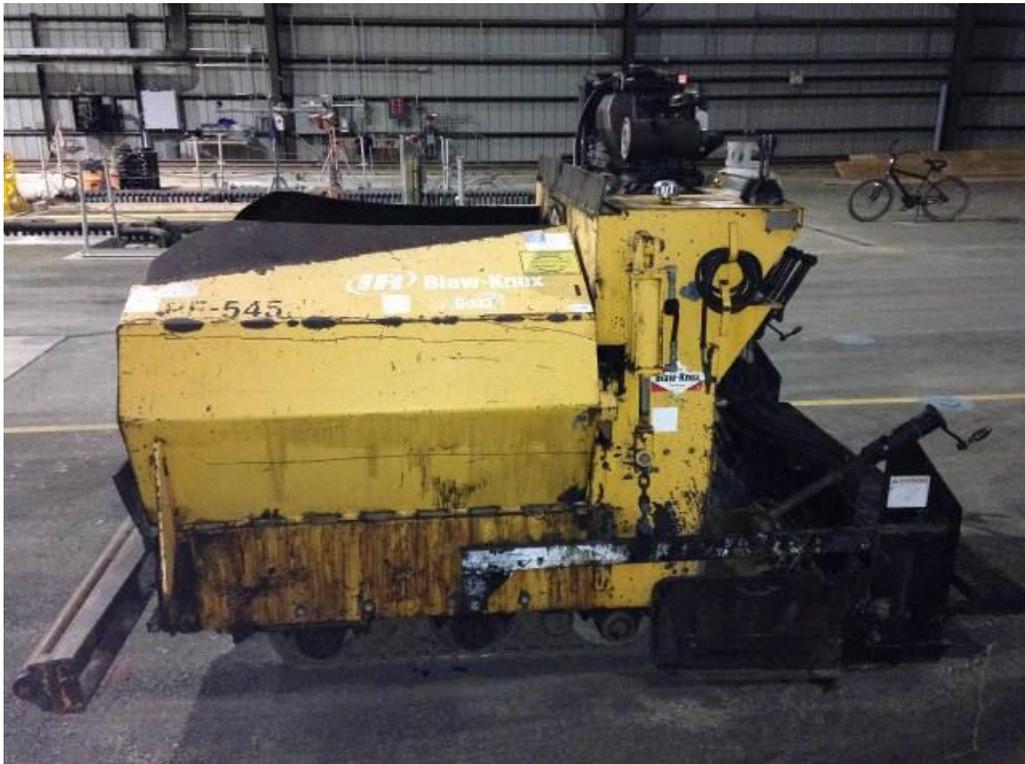
Glasgow, Inc. delivered an IR Blaw-Knox PF-545 pathway paver to the NAPTF in the morning. This paver will be used to pave Phase IV of Reflective Cracking tomorrow (12/18/2014). The IR Blaw-Knox paver, shown in Figure 3, has a track width of 15 inches and an out-to-out dimension of 52 inches.

Figure 3. The IR Blow-Knox Paver.
