## **Reflective Cracking Construction Notes**

**Date:** December 18, 2014

**Project:** Reflective Cracking Indoor Phase IV

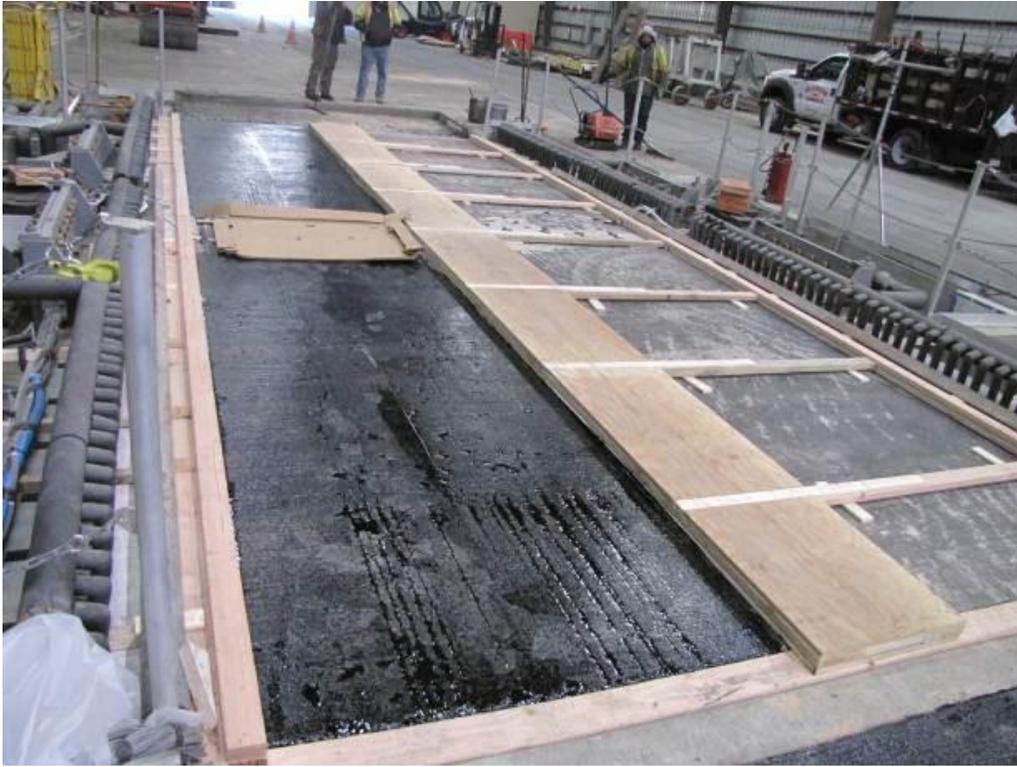
(a) Paving (1).

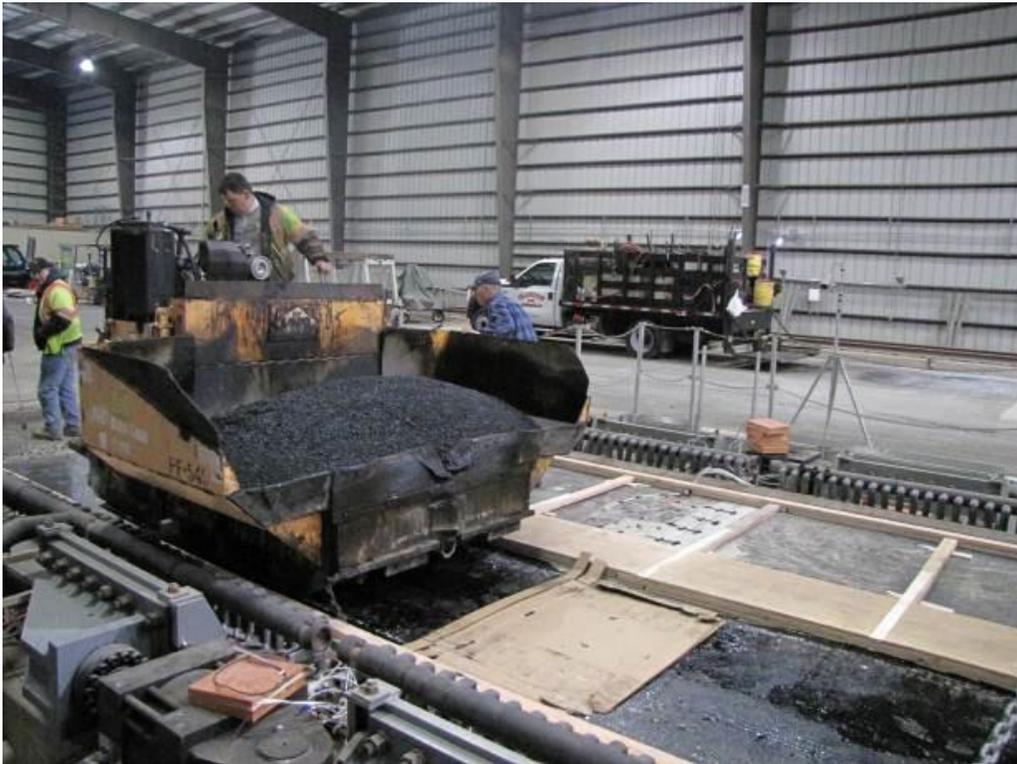
(b) Paving (2).

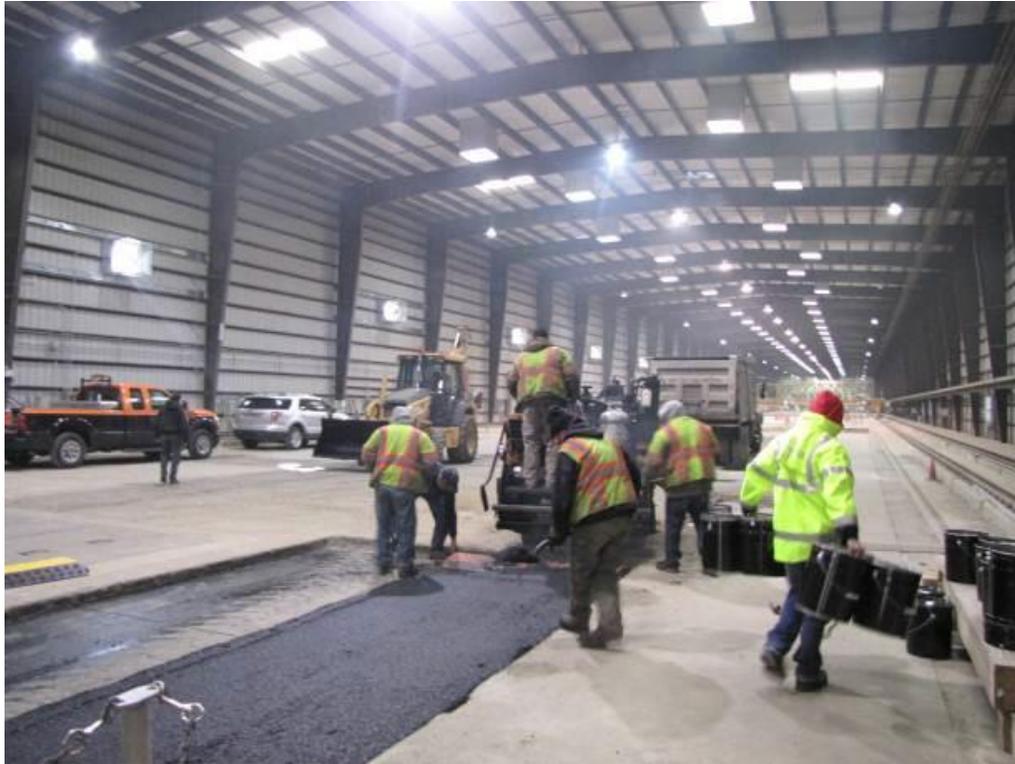
(c) Paving (3).

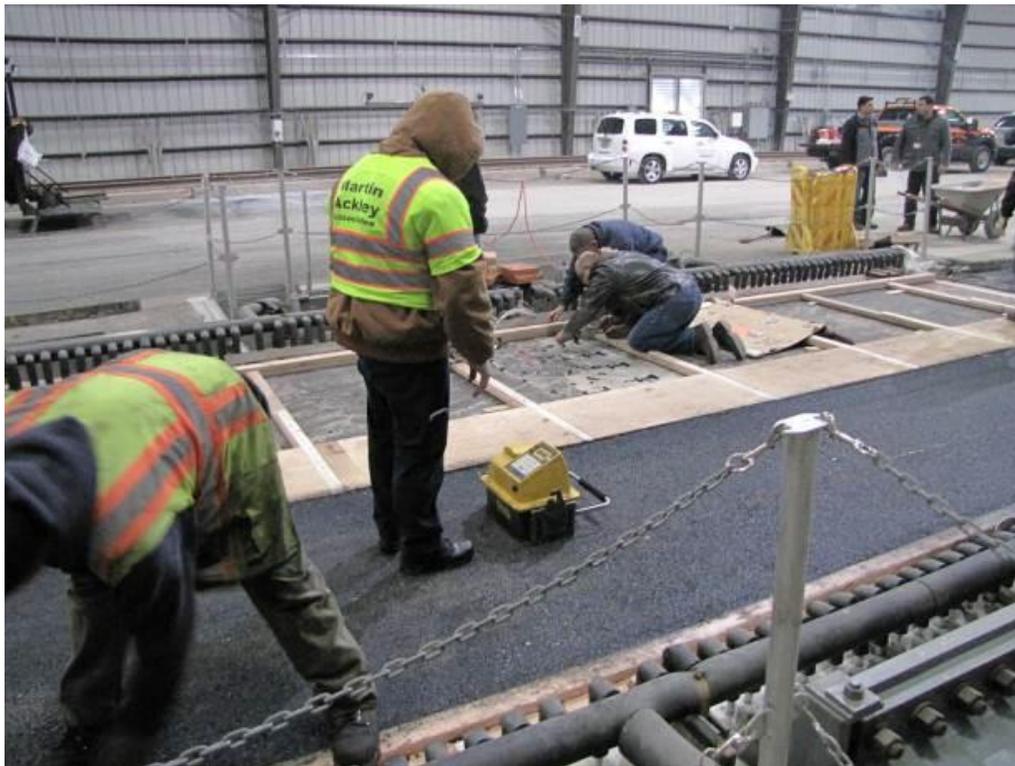
(d) Testing Compaction.

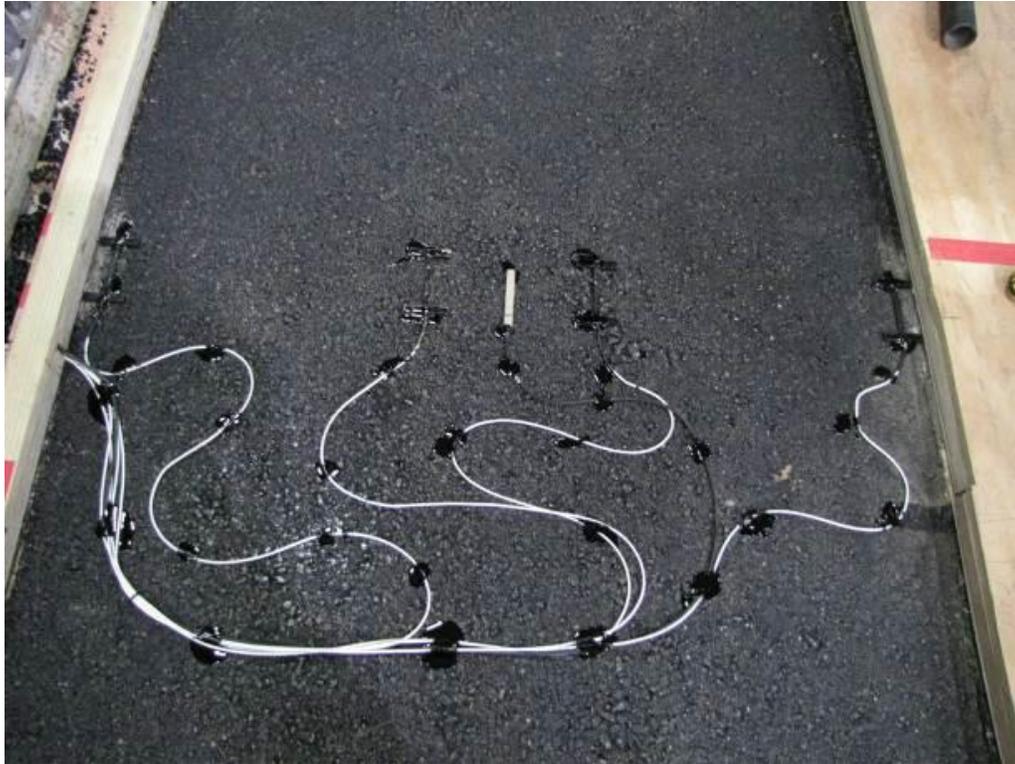
(e) Gauge Installation, and Wire Routing and Tacking.

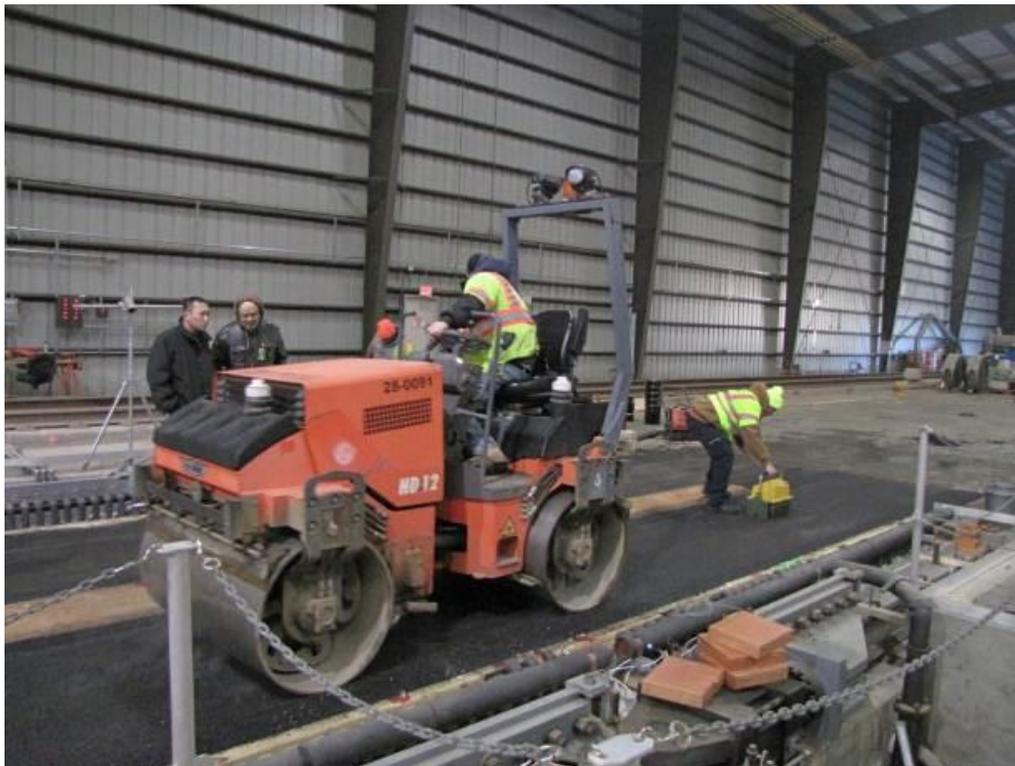
(f) Compaction.
