Reflective Cracking Outdoor Phase I Comprehensive Report
Part B –Test Report

August 2020

DOT/FAA/TC-TNxx/xx

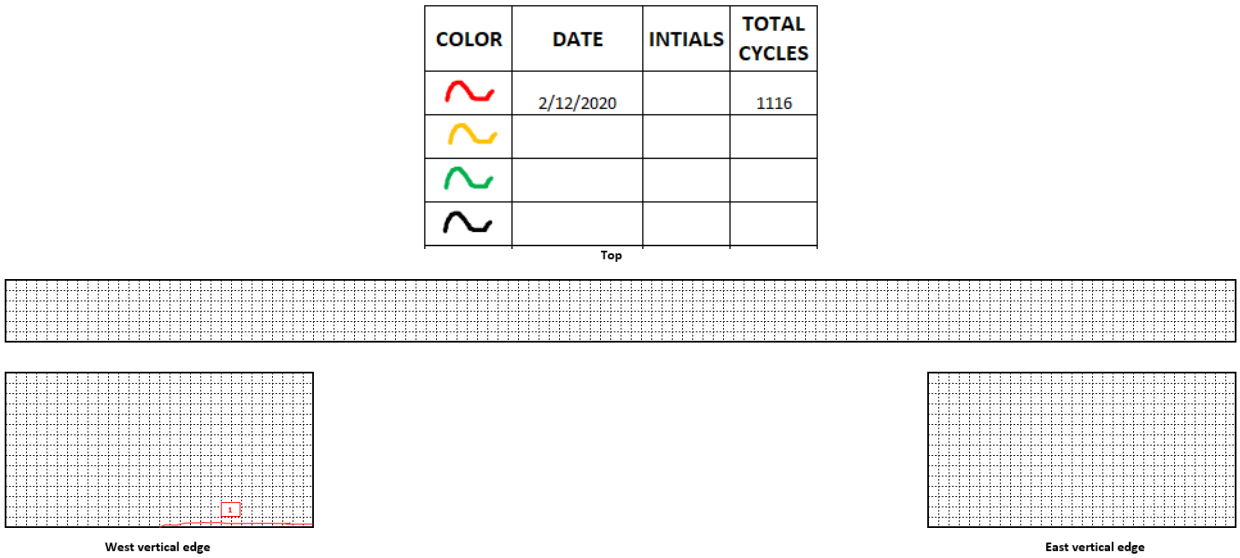
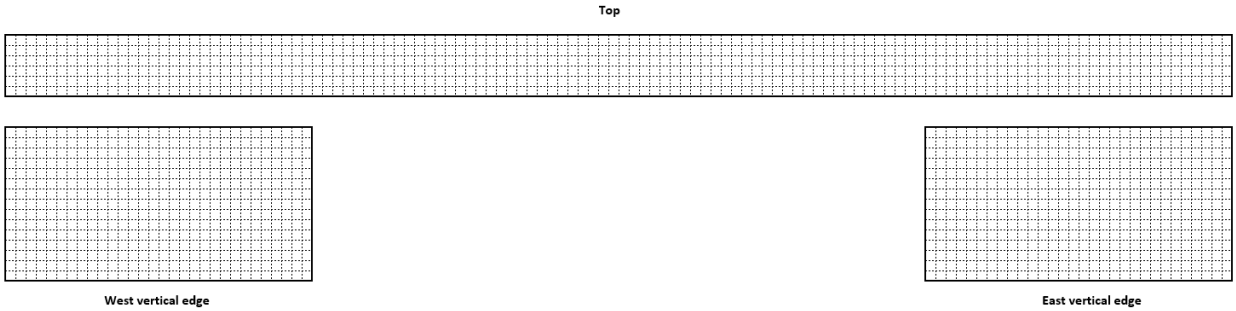
Figure 11. Sample Distress map (Portion).

As shown in table 8, reflection cracks were first observed on the 2nd day of traffic testing (i.e., February 12, 2020) after cumulative pass #1162. These cracks were located on both the east and west sides along joint TT34, TT45, and TT56. After initiation, the progress of bottom-up cracks varied. For example, on the west side of joint TT45, the crack reached the 1.4-inch mark (as measured from the bottom of the overlay) as reported on February 14, 2020, after pass no. 2356. Photos of these cracks are included in Appendix A.

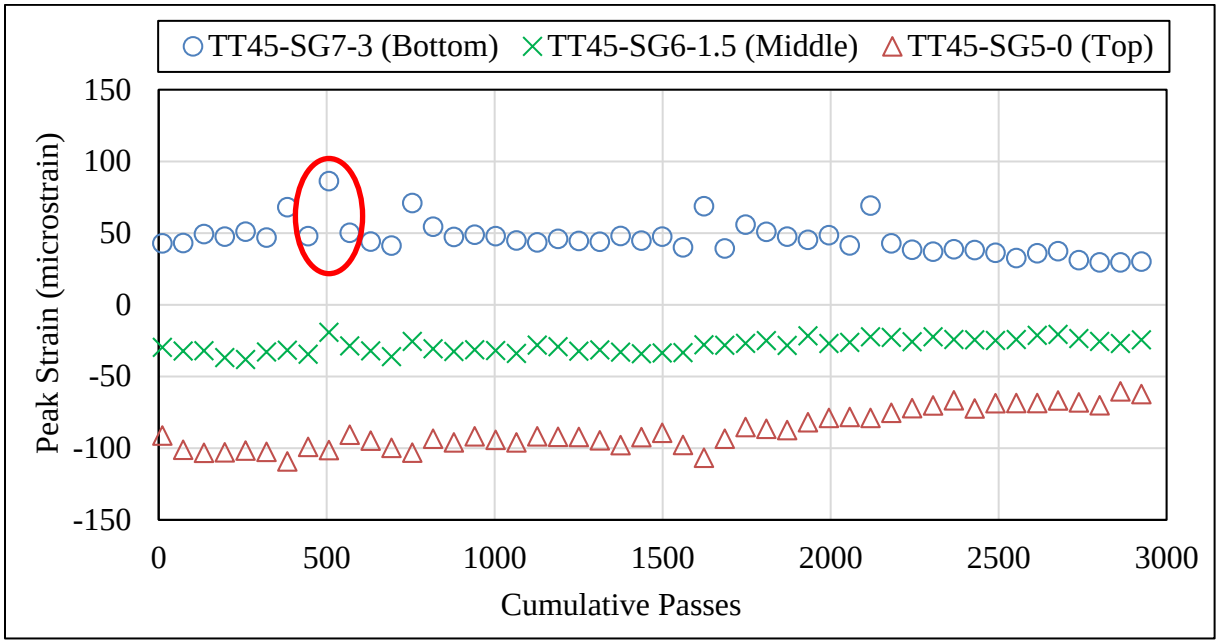
Figure 24. SG Response over Pass Number at the West Edge of TT45.

CRACK CHARACTERIZATION. On February 12, 2020 (2nd day of trafficking), the first bottom-up crack was observed on the west vertical edge of TT45 (undoweled joint) after cumulative pass #496 (figure 23). In figure 24, some strain fluctuation from the bottom SG first manifested at cumulative pass #507, while strains from the upper two SGs remained fairly stable. Crosscheck of joint displacement readings from TT45-JDG2-5 identified the initial jump at the same pass number (figure 25). Therefore, the pass number corresponding to the crack initiation at this location was determined to be 507. Strain and joint displacement trends from other SG, EG, and JDG are included in Appendices E and F.

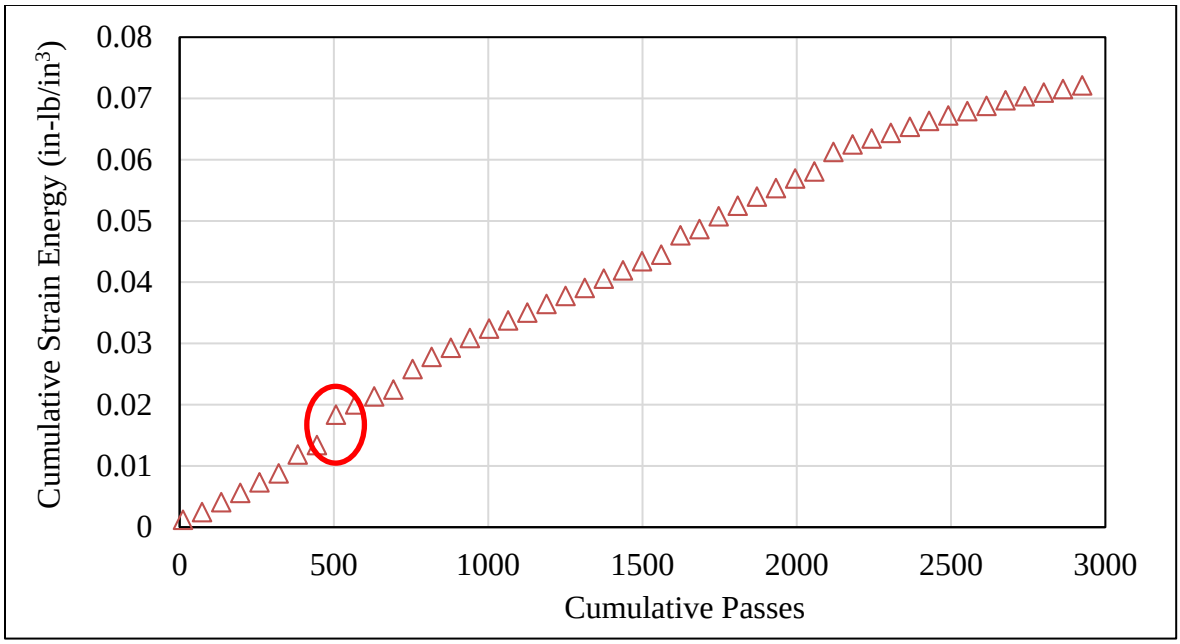
Figure 26. Cumulative Strain Energy Calculated from TT45-SG7-3.0 along West Edge of TT45.

Following the analysis of Indoor Phase VI Test data, cumulative strain energy was then calculated using the tensile strains from TT45-SG7-3.0. As shown in figure 26, there was an apparent upshift in the trend of cumulative strain energy at pass #507. This observation further confirmed the timestamp of the bottom-up crack initiation.

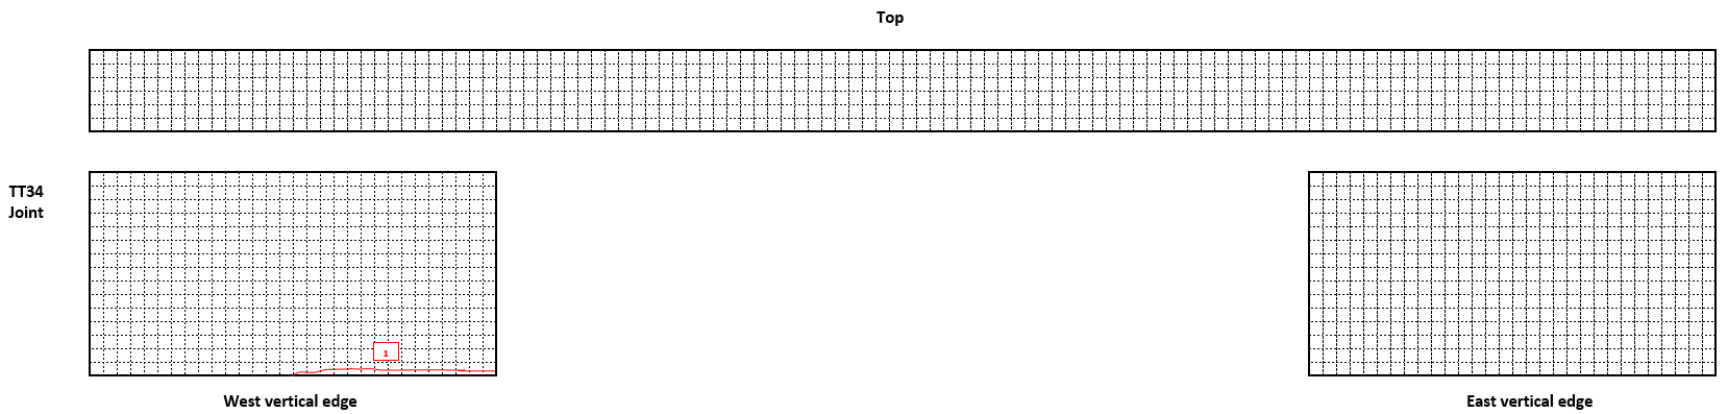
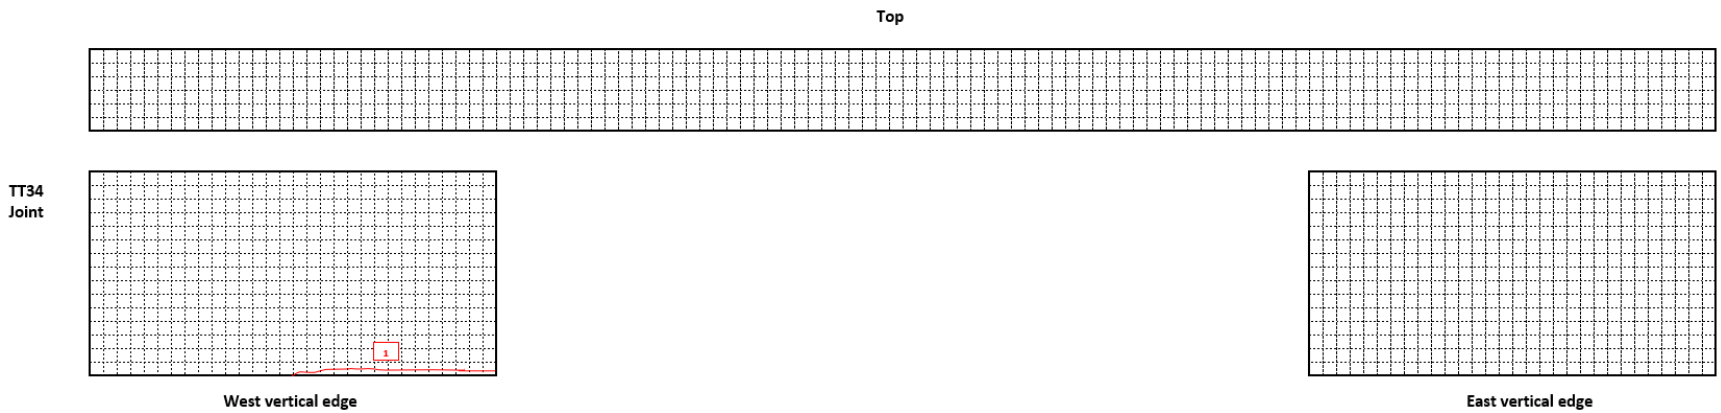
Figure B.3: Joint#3 (TT34)

Day	Date	Cumulative Passes	Distress Observation
1	2/11/2020	496	No crack initiated
2	2/12/2020	1162	(a) TT34 joint west side: 3 mm (approximate) vertical hairline crack, in asphalt at concrete joint, then the hairline crack moved to the right for 40 mm (approximate) parallel to the concrete surface (b) TT45 joint west side: 10 mm (approximate) vertical hairline crack, in asphalt at concrete joint at approximately 45 degrees to the left, then the hairline crack moved to the right for 40 mm (approximate) parallel to the concrete surface (c) TT45 joint east side 4 mm (approximate) vertical hairline crack, in asphalt at concrete joint at approximately 45 degrees to the left, then the hairline crack moved to the right for 40 mm (approximate) parallel to the concrete surface (d) TT56 joint west side: 2 hairline vertical cracks 4 mm each at the joint then moved 50 mm individually one to the right the other to the left of joint parallel to the concrete surface (e) TT56 joint east side: 4 mm (approximate) vertical hairline crack, in asphalt at concrete joint, then the hairline crack moved to the right for 30 mm (approximate) parallel to the concrete surface

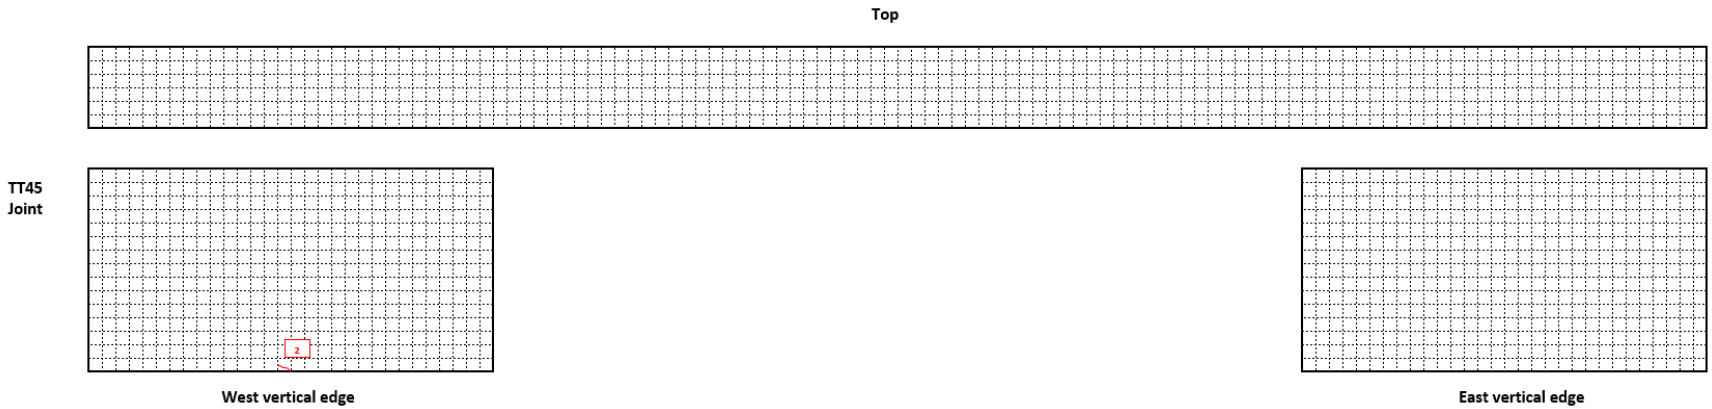
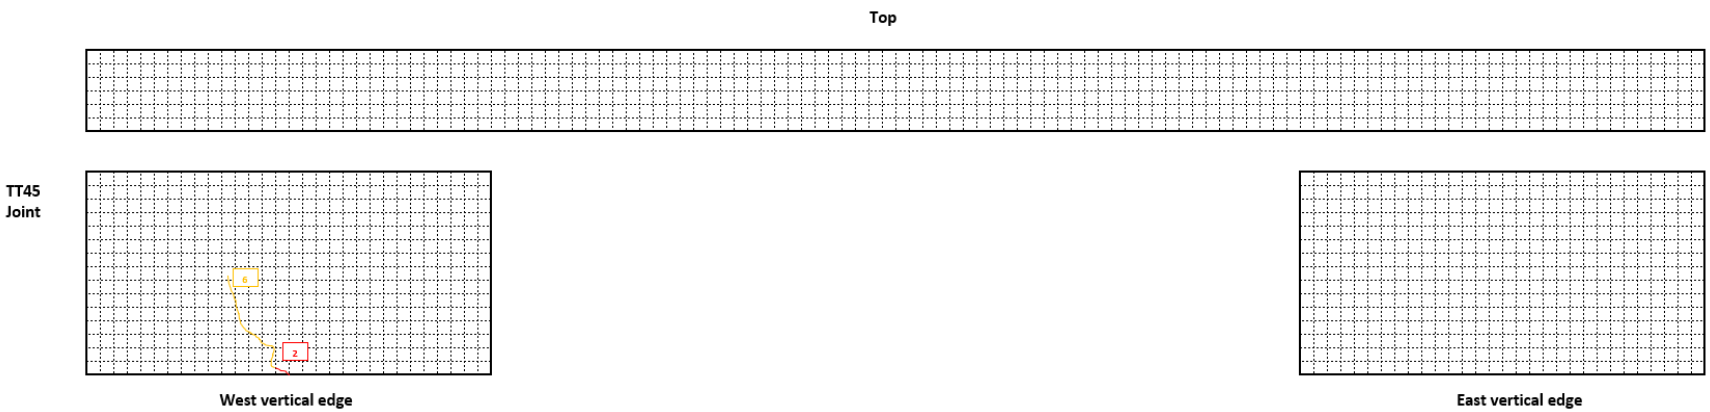
Figure B.4: Joint#4 (TT45)

3	2/13/2020	1736	No further propagation observed on the existing crack
4	2/14/2020	2356	(a) TT45 joint west side: Bottom up crack reaches the height of 1.4 inch (b) No further propagation observed on other joints
5	2/18/2020	2976	No further propagation observed on the existing crack
