Contract No. DTFACT-15-D-00007  
Construction Cycle 8: Phase I Test Report  
DELIVERABLE 4.9.2

February 2017

Prepared by Dr. Hao Yin, Gemini Technologies, Inc.

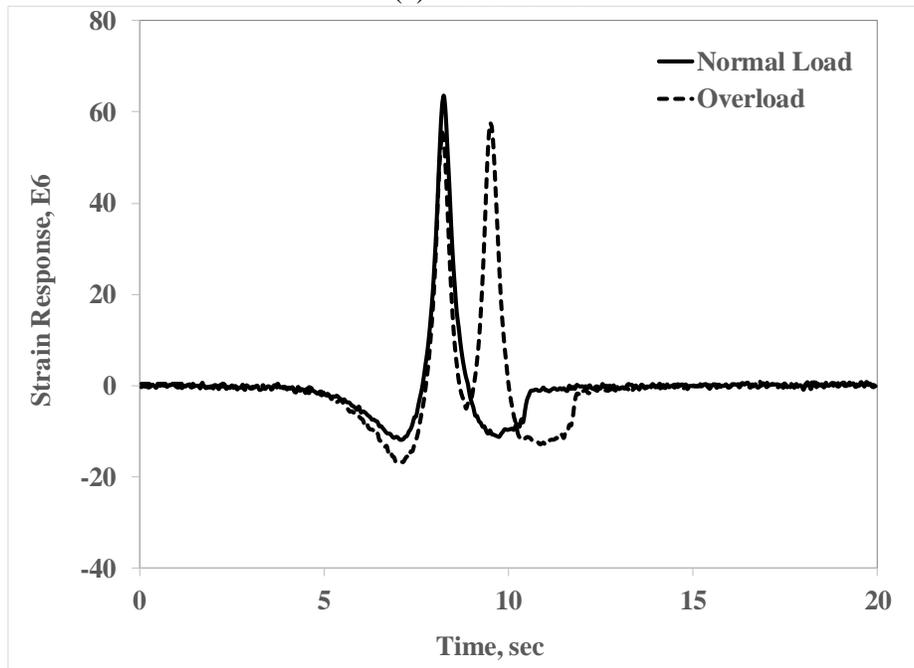
Figure 19. Sample Embedded Strain Gage Responses.

For demonstration purpose, sample strain responses from EG-S-O-I-3 and EG-S-O-I-8 during normal traffic and initial overload test are provided in figures 19a and 19b, respectively. Along the transverse joint, EG-S-O-I-3 experienced slab surface tension only. The longitudinal strain gage (EG-S-O-I-8) recorded a counter-strain as the load approached and another strain reversal as the load left. Note that the steep post-peak strain recovery was a result of the formation of transverse joint at STA 3+54 (figure 19b). In addition, the peak strains did not vary with the passage of each subsequent axle. Compared to the normal traffic, the overloads induced a higher peak tensile strain at the slab surface and smaller peak tensile strains at the bottom of the slab. This observation agrees with the previous findings at the NAPTF that the tensile stresses developed at the slab bottom were related primarily to the wheel load, while the tensile stresses on the slab surface were related primarily to the gear load at both the longitudinal and transverse joint locations (Brill 2011).

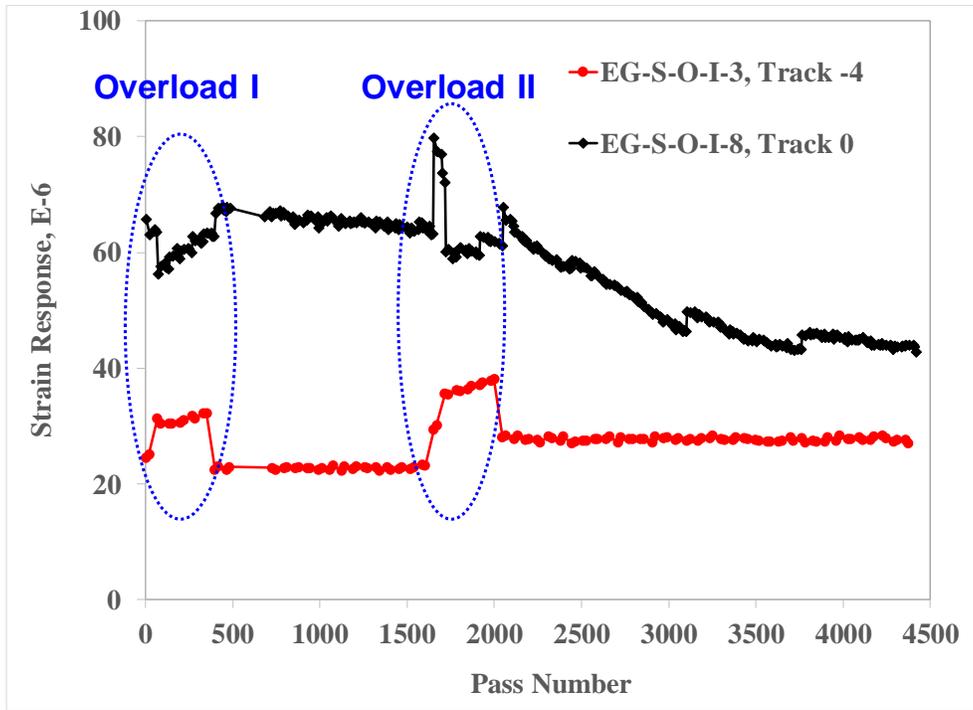
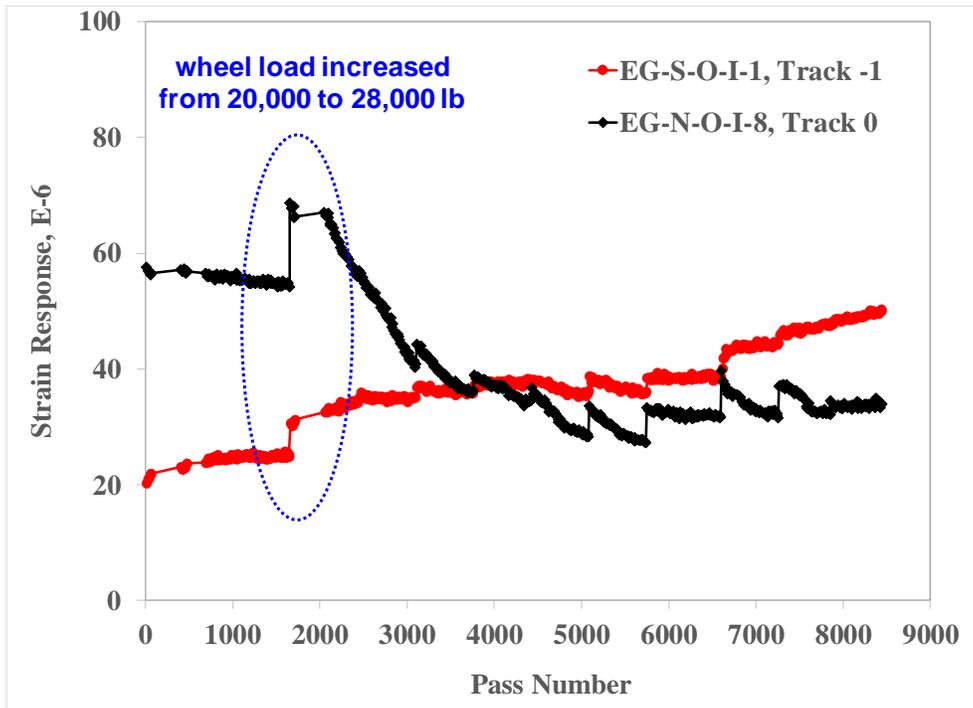
Figure 20. Strain Response History.

Figure 20 contains a history plot of peak tensile strains from all four monitoring embedded strain gages. For the south test item, the tensile strains at the slab bottom were always higher than those on the surface. Neither of the gage responses indicated a crack initiation. After a quick recovery from the peak response of 40 microstrains under the highest overload, the tensile strains from transverse gage (EG-S-O-I-3) remained steady at 30 microstrains till the end of traffic

testing, indicating no load-induced damage close to the slab surface. On the other hand, a gradual decline in strain was registered by EG-S-O-I-8 at the slab bottom along the longitudinal joint. For the north test item, the initial tensile strains at the slab bottom were much higher than those on the surface. Then the bottom strains steadily decreased and the surface strains increased, and eventually crossed each other after 4000 passes. There was also a distinct jump in the responses due to the increase of wheel load from 20,000 lbs to 28,000 lbs. The maximum bottom tensile strain was about 80 and 70 microstrains for the south and north test item, respectively. The application of overloads seemed to have a minimal effect in strain responses.

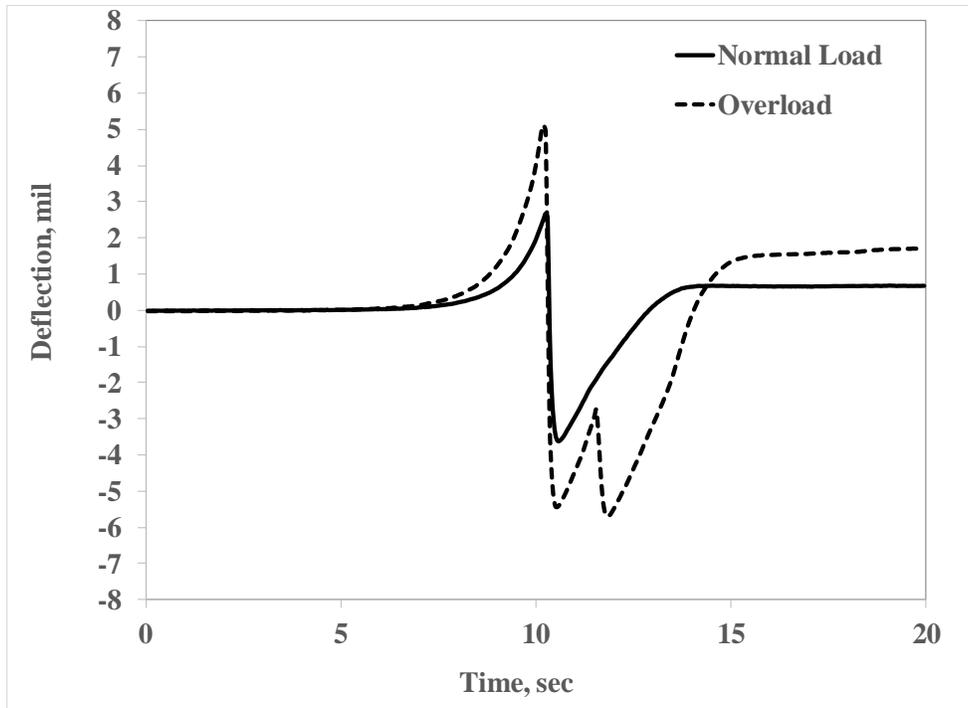
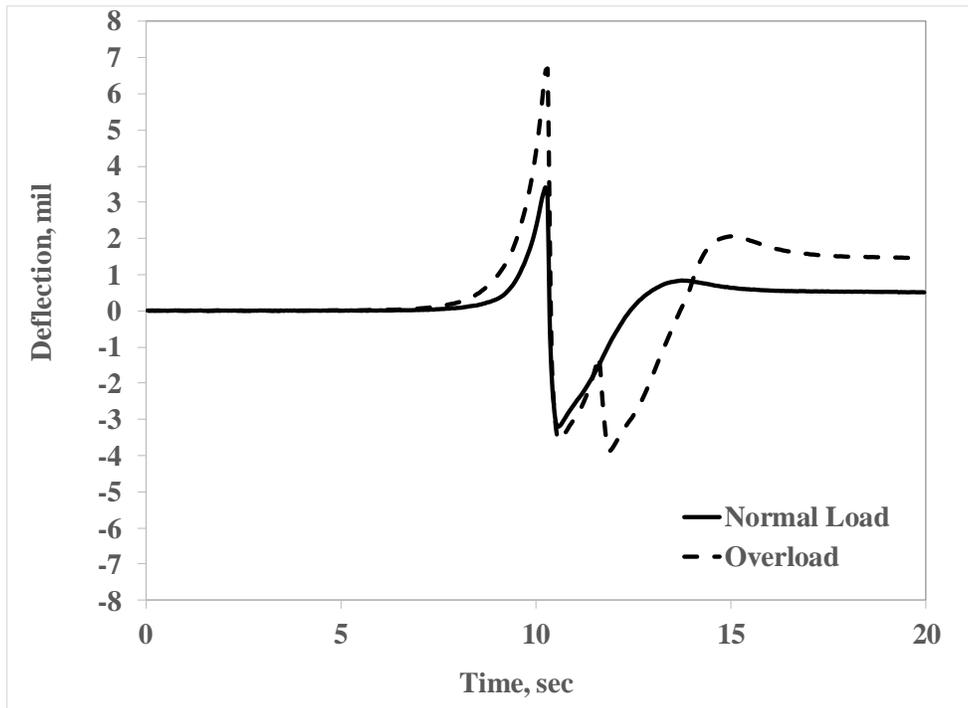
Figure 21. Deflection Sensor Responses.

Deflections at the west corners of Slab 3S and 8S were measured by ECS. Two ECS sensors were installed on a trial basis on the south test item only. The ECS sensors performed well and will be used more extensively in the second phase of CC8 and in future applications. Referring to the ECS locations in figure 1, and the wander pattern in figure 3, the maximum deflections were recorded on Track 1 for ECS-S-O-I-1 and on Track 0 for ECS-S-O-I-2. For those particular wander positions, one wheel passes directly over the slab corner associated with the sensor. Sample deflection responses are presented in figures 21a and 21b. As the wheel approached the transverse joint, the deflection sensor on the opposite slab recorded an upward deflection followed by an abrupt downward movement as the wheel crossed the joint. The peak negative response corresponds to the wheel position directly above the slab corner. The load-induced deflections gradually recovered as the wheel left the slab. The magnitude of peak deflections depends not only on the wheel load, but also on the gear configuration. In contrast to the full deflection recovery under D gear loads (normal loads), there was some upward residual deflection (negative rebound) observed after each 2D (overload) gear passage, perhaps resulting from the partial recovery between axles. For both normal traffic and overloads, ECS-S-O-I-1 recorded somewhat higher peak deflections, indicating a slightly lower level of support under the west corner of Slab 3S, compared with Slab 8S. Nevertheless, the deflections recorded by the two sensors under equal loads are very similar.

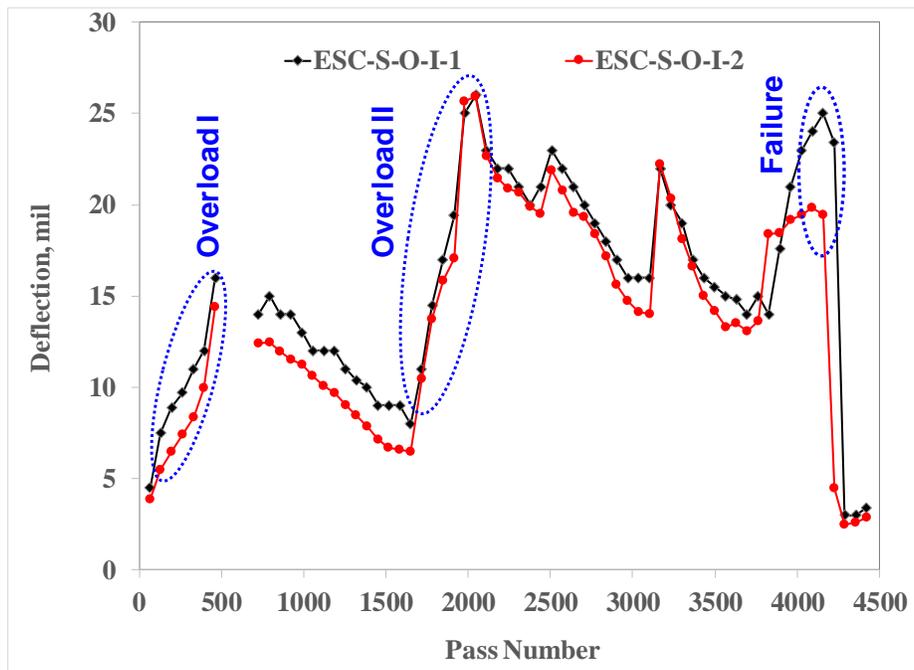
Figure 22. Deflection Sensor Response History.

In Figure 22, peak deflections from ECS-S-O-I-1 and ECS-S-O-I-2 are plotted against accumulated load passes. In this plot, positive deflections are downward. In both cases, peak downward deflections at slab corners increased rapidly under the overload traffic, then gradually recovered under subsequent normal traffic. An interesting observation concerns behavior during overnight rest periods. When the traffic test resumed in the morning (approximately 7:30 am), there was always an increase in deflection compared to the end of traffic on the previous day, which was attributed to the upward movement in the slab during the night. At failure, there was a sudden drop in peak deflection response (over 20 mils), suggesting that the developing cracks had destroyed the slab flexure completely. Corresponding to this change, after 4,158 total passes, cracks became visible on the surface of Slabs 3S and 8S.

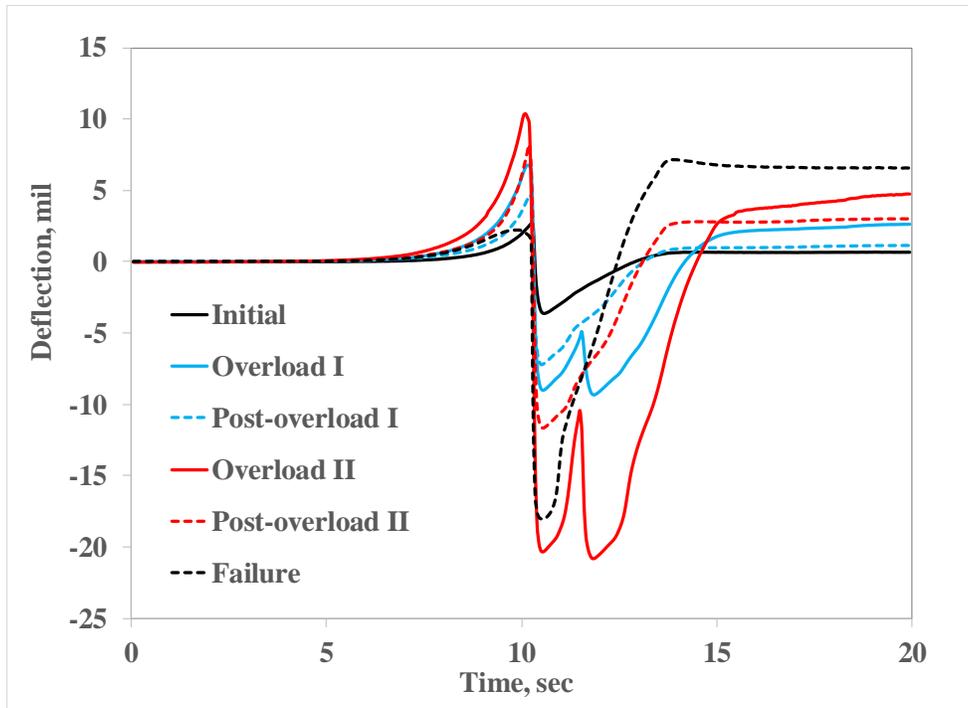
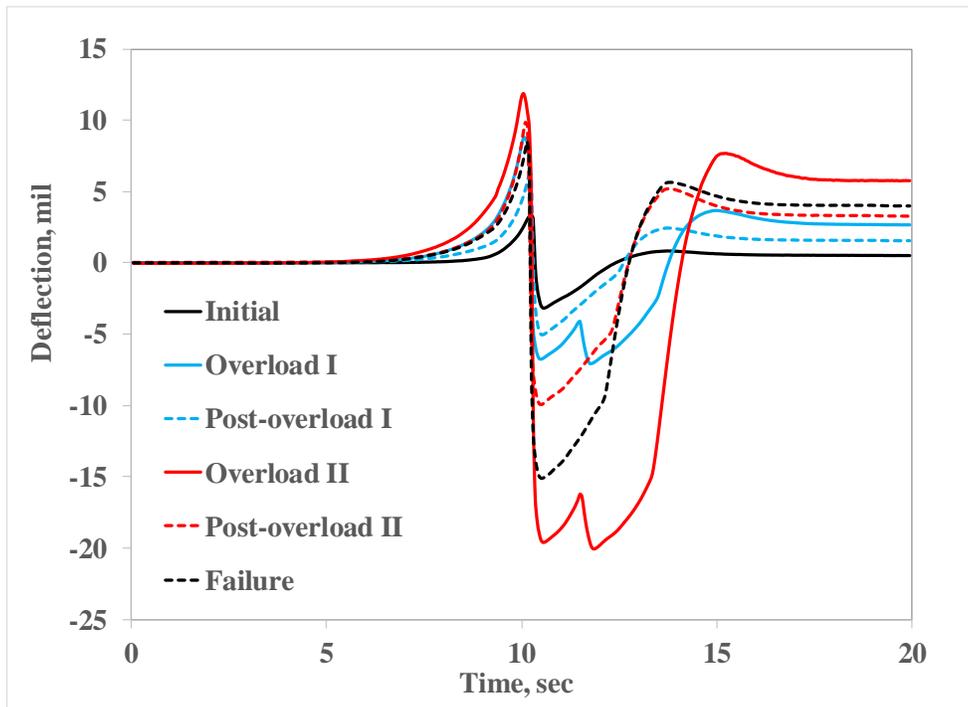
Figure 23. Deflection Responses Extracted from Different Testing Periods.

To further examine the failure at slab corners, deflection responses were extracted from different phases of traffic and a comparison of these responses is presented in figure 23. It is clear that the total load-induced corner deflection was a combination of the downward movement under the loads and the upward residual movement following the loads. The ratio between these two opposite movements was controlled by the wheel load. During the second overload traffic, the contribution from the residual deflections was as high as 25 percent of the peak deflections. A reasonable conclusion is that the overloads formed voids under slab corners, produced negative rebound along the outer edge of the slab, and eventually initiated cracks on the surface.

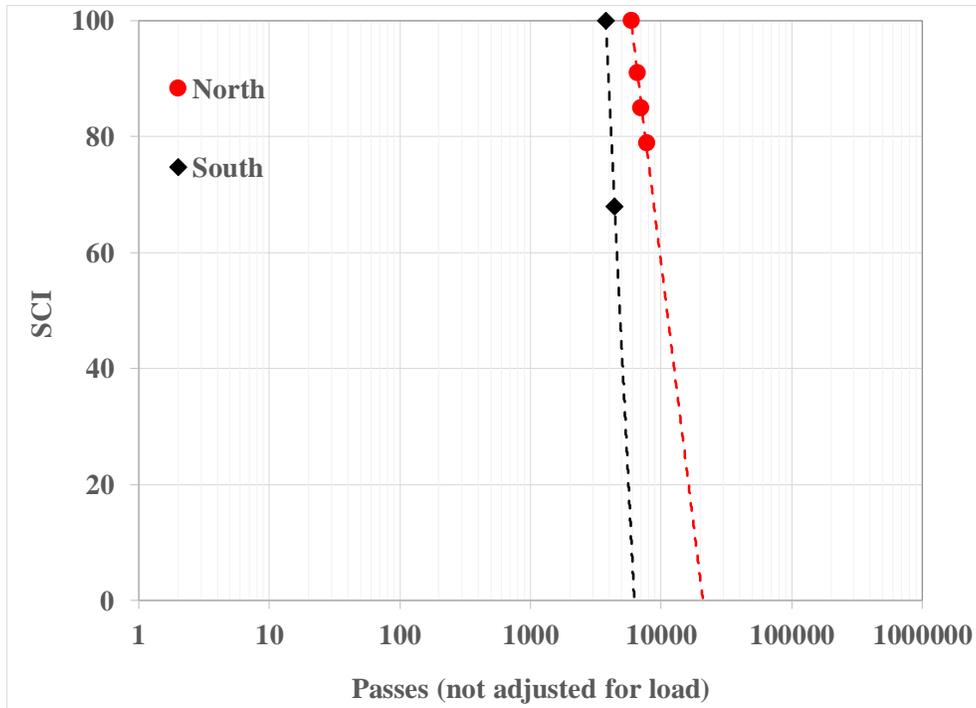
Figure 25. SCI as a Function of Traffic Passes.

To reasonably compare the performance of different test items in a meaningful way, an analytical procedure (Brill and Kawa 2014) was adopted here to compensate for different load levels. The first step was to determine the number of traffic passes to failure. In this analysis, for purposes of comparison between test items, the failure condition was selected at SCI 80. As shown in figure 25, the total number of passes to SCI 80 were obtained by linear regression through the semi-log plots of SCI versus passes: 7582 for the north and 4156 for the south.

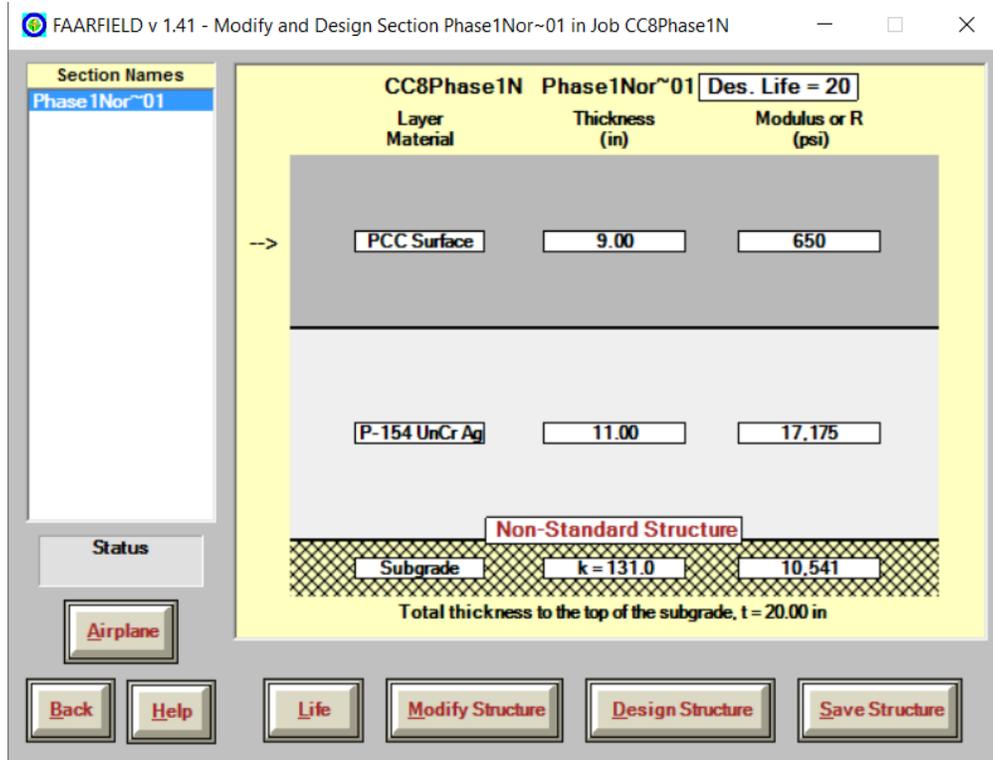
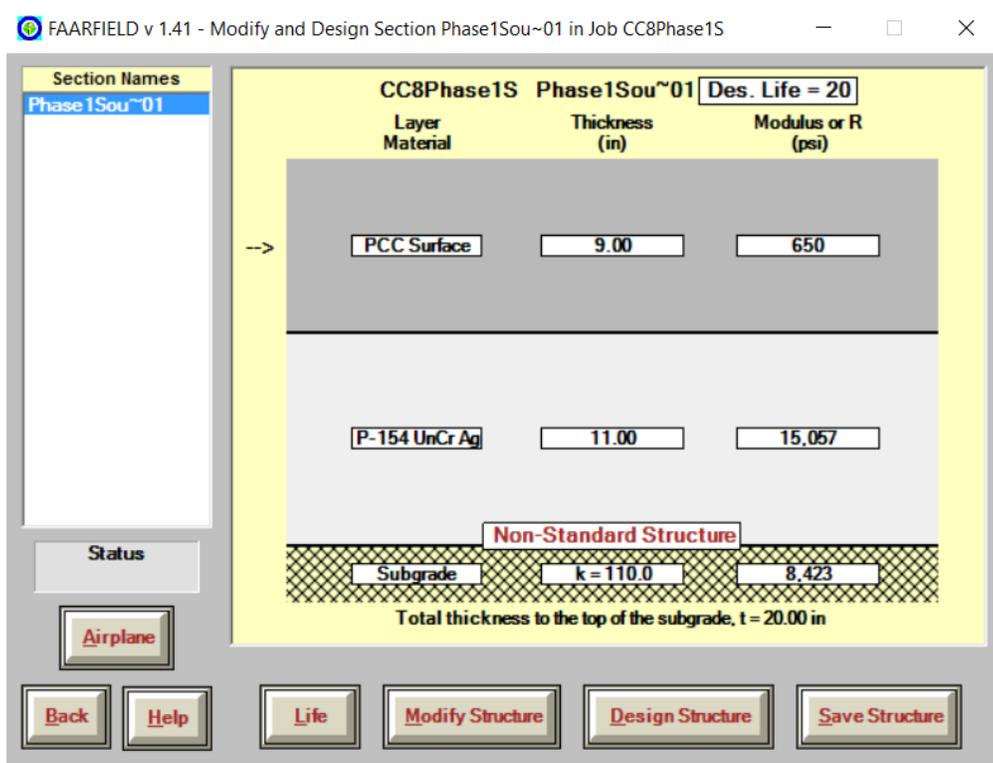
Figure 26. FAARFIELD 1.4 Comparative Life Computations.

Next, the FAA pavement thickness design program FAARFIELD was used to compute the pass/coverage ratio and then convert traffic passes to coverages (figure 26). As summarized in table 4, a total of 1300 and 697 coverages were required for the north and south test item to reach the same failure condition, respectively. Stresses in table 4 are the maximum concrete bending stresses computed by FAARFIELD, version 1.4. Note that all inputs were the same for both test items except for the k-value of subgrade: 131 pci for the north and 110 pci for the south.

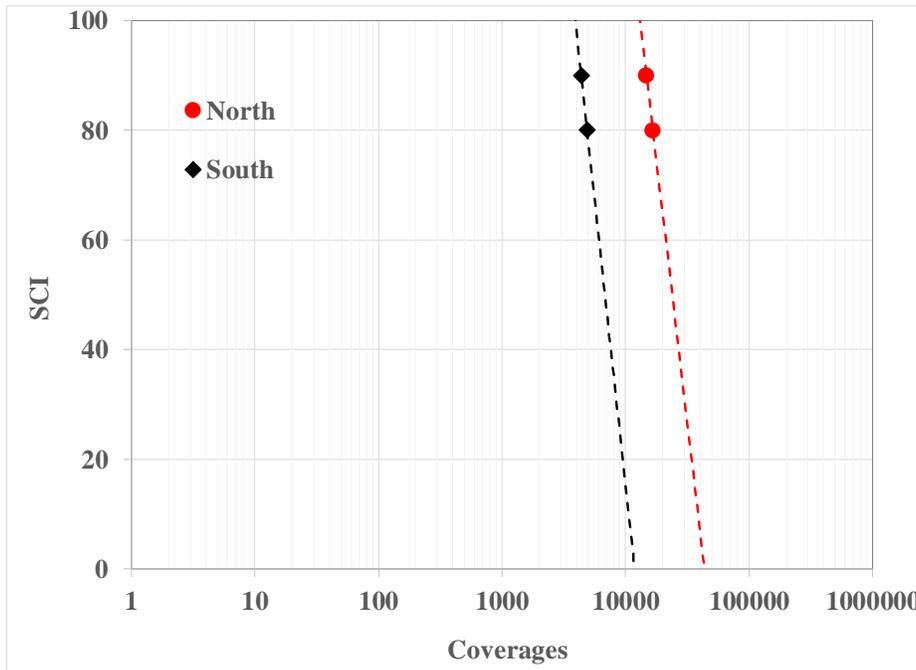
Figure 27. SCI as a Function of Coverages.

In figure 27, the structural deterioration for both test items are plotted versus cumulative coverages on a logarithmic scale to correspond to traditional plotting of fatigue relationships. This performance curve is a key product of this research effort, and two important observations can be obtained from it. At the same reference load level, overloads considerably shortened pavement fatigue life up to the first full-depth crack (i.e., at which SCI just begins to diminish from its initial level of 100). In addition, figure 27 suggests that overloads did not affect the rate of structural deterioration (slope of the falling leg of the SCI-vs-log(C) curve).
