Contract No. DTFACT-15-D-00007
Delivery Order 005 NAPTF Support
Deliverable 4.9.2.4
Construction Cycle 8 Phase II Overlay Testing Report

July 2018

**Prepared by Carlos Cary, Ph.D., Mesbah Ahmed, Ph.D. and Hao Yin, Ph.D. P.E.
Gemini Technologies, Inc.**

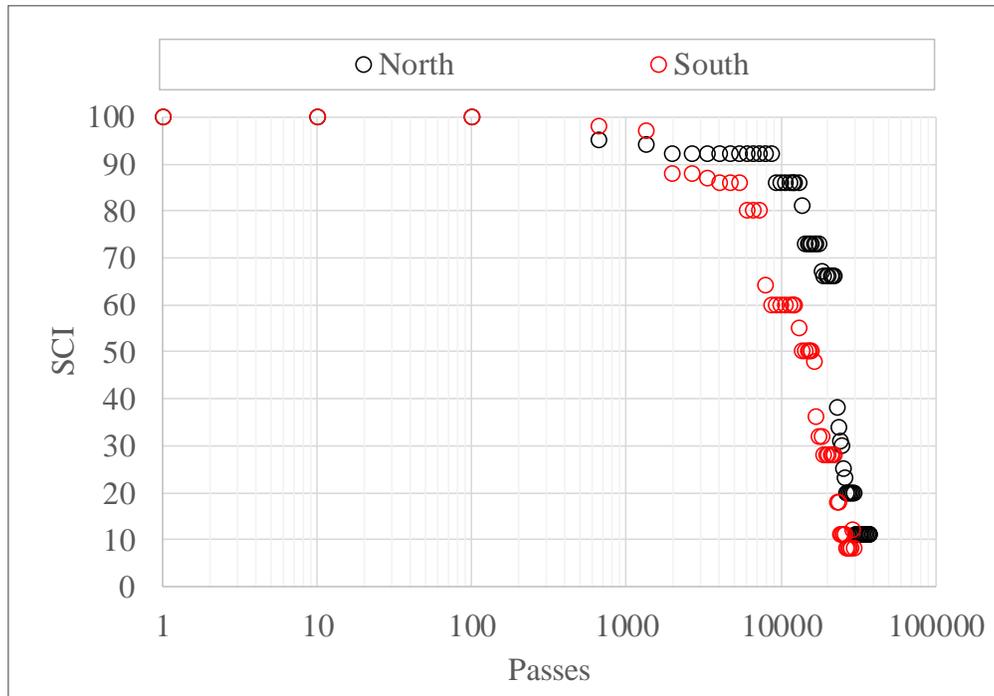
Figure 15. Overlay Structural Condition Index versus Passes

Figure 15 illustrates the changes in SCI for each test item over the course of trafficking. The deterioration in the south test item is evidently faster than the north. The total number of vehicle passes required to achieve similar levels of deterioration upon traffic termination was 37,290 for the north test item whereas only 29,370 for the south test item. Under comparable structural conditions the north test item would be expected to fail first given that the 3D gear configuration is 50% heavier than the 2D used in the south. In Table 6, a comparative summary of the as-built properties of both test items is presented. Statistically, except for the k-value of P-154 subbase material, there was little to no discrepancy in as-built properties between the north and south test item. Furthermore, the fact that the P-154 layer in the south test item presented a higher k-value than the north, indicates stronger support conditions underneath the underlay in the south which in turn should contribute to extend rather than reduce the pavement life. Therefore, as-built properties can be ruled out as source of unexpected rapid deterioration in the south test item.

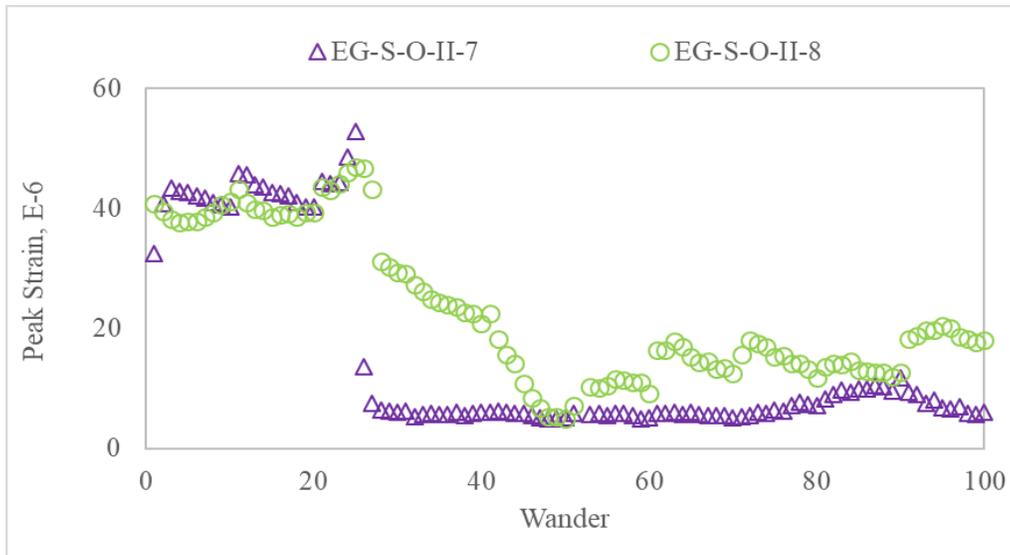
Figure 24. Peak Strains for EG-S-O-II-7 and EG-S-O-II-8

The maximum strain responses from multiple sensors showed significant changes during the traffic test. Figure 24 shows sharp drops in the responses of EG-S-O-II-7 and EG-S-O-II-8 took place during the third day of trafficking. On the same day, the occurrence of a corner break was reported in the distress survey (Figure 25). The changes in EG responses allow for a more accurate estimate of both the crack initiation time and, potentially, the time of completion for crack propagation to the bottom of the slab in the case of a top-down crack.

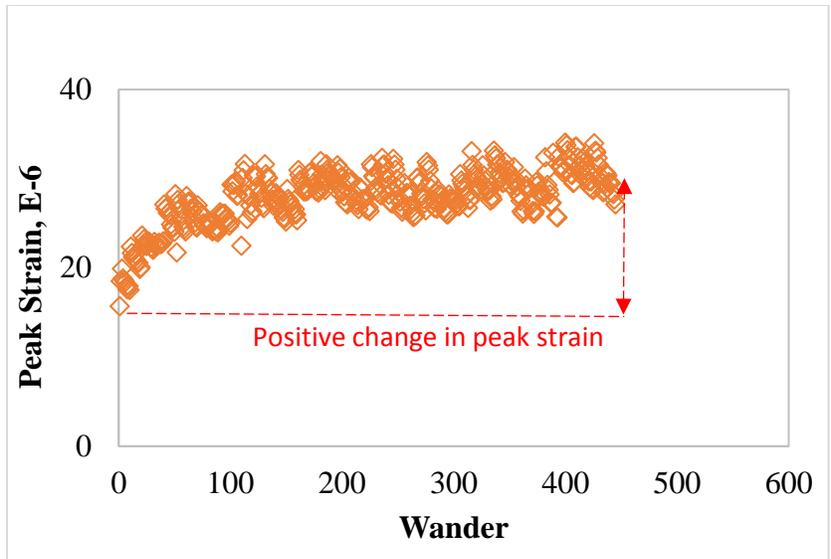
Figure 26. Peak Strain Change of EG-S-O-II-9 Due to Trafficking

Given that the original CD value was estimated for the entire slab, its ability to capture and reflect the effect of localized distress became limited. Figure 26 shows that the strain responses of EG-S-O-II-9 in slab O9S increased from 16 to 30 microstrain, which may be an indication of crack development or local damage near the embedded sensor. However, as shown in Figure 27, minimum surface cracking was observed on slab O9S whereas significant cracking was observed on the adjacent slab O4S. A localized crack density (LCD) parameter was introduced as illustrated in Figure 27. The LCD was calculated as the percent of discrete units where cracking was observed within a virtual 12×12 ft. slab centered on the sensor of interest.

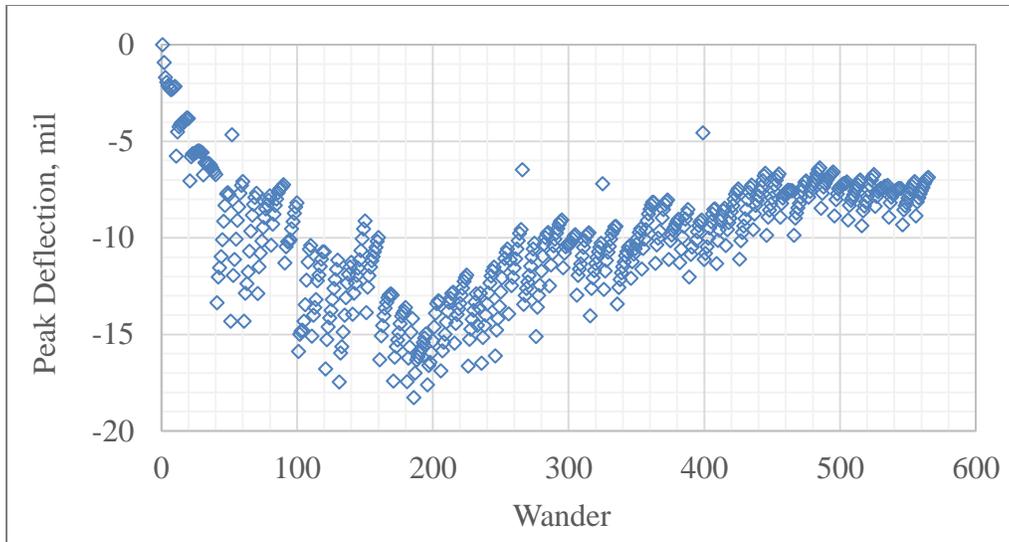
Figure 35. Change in ECS-N-O-II-2 Maximum Response with Traffic for the Critical Track

The response captured by the ECS corresponds to the separation between two concrete layers. Most ECSs showed nearly constant responses of negligible magnitude (i.e., less than 5 mil) throughout the course of the traffic test. However, the maximum deflections observed for ECS-N-O-II-2 and ECS-S-O-II-1 ranged between 10 and 20 mils, and the response of these two ECS were found to correlate with the occurrence of distresses within the sensor vicinity. In Figure 35, the maximum deflection of ECS-N-O-II-2 is initially observed to become more negative (i.e., increasing absolute deflection). Beyond wander 195 the trend reverted so that the maximum deflection became less negative (i.e., decreasing absolute deflection) with additional trafficking. This inflection point is consistent with the occurrence of a longitudinal crack (see red marked crack in Figure 36), which took place between wanders 195 and 205.

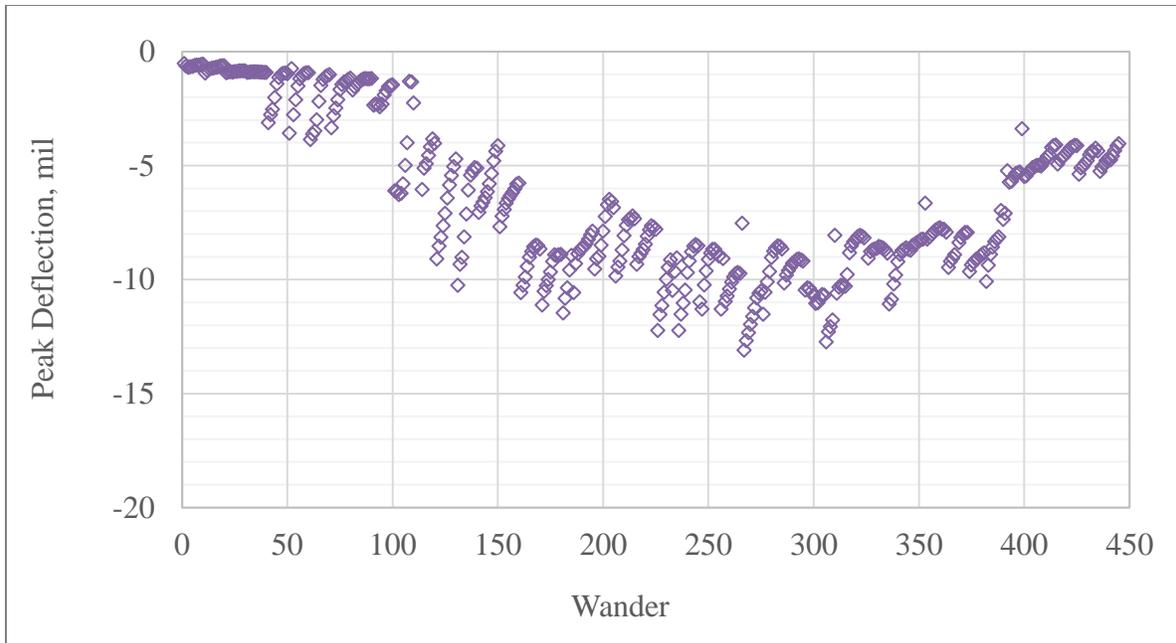
Figure 37. Change in ECS-S-O-II-1 Maximum Response with Traffic for the Critical Track

Figure 37 shows the change in the maximum deflection response of ECS-S-O-II-1. Past wander 100, an increase in the rate of change in maximum deflection was observed. Between wander 255 and 265, the maximum deflection began to level off. This is consistent with the occurrence of the corner break shown in Figure 38, which took place within the same timeframe.

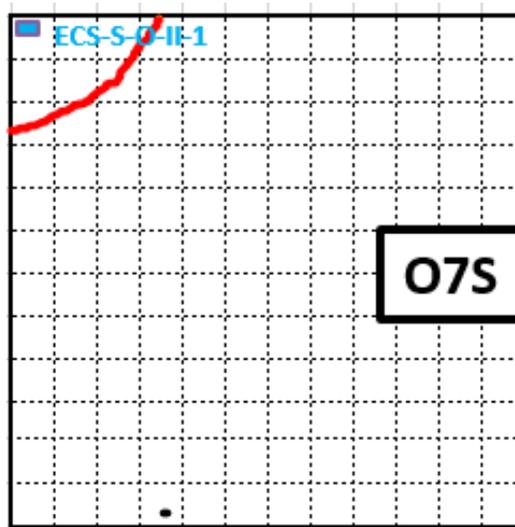
Figure 38. Corner Break Captured by ECS-S-O-II-1 Response

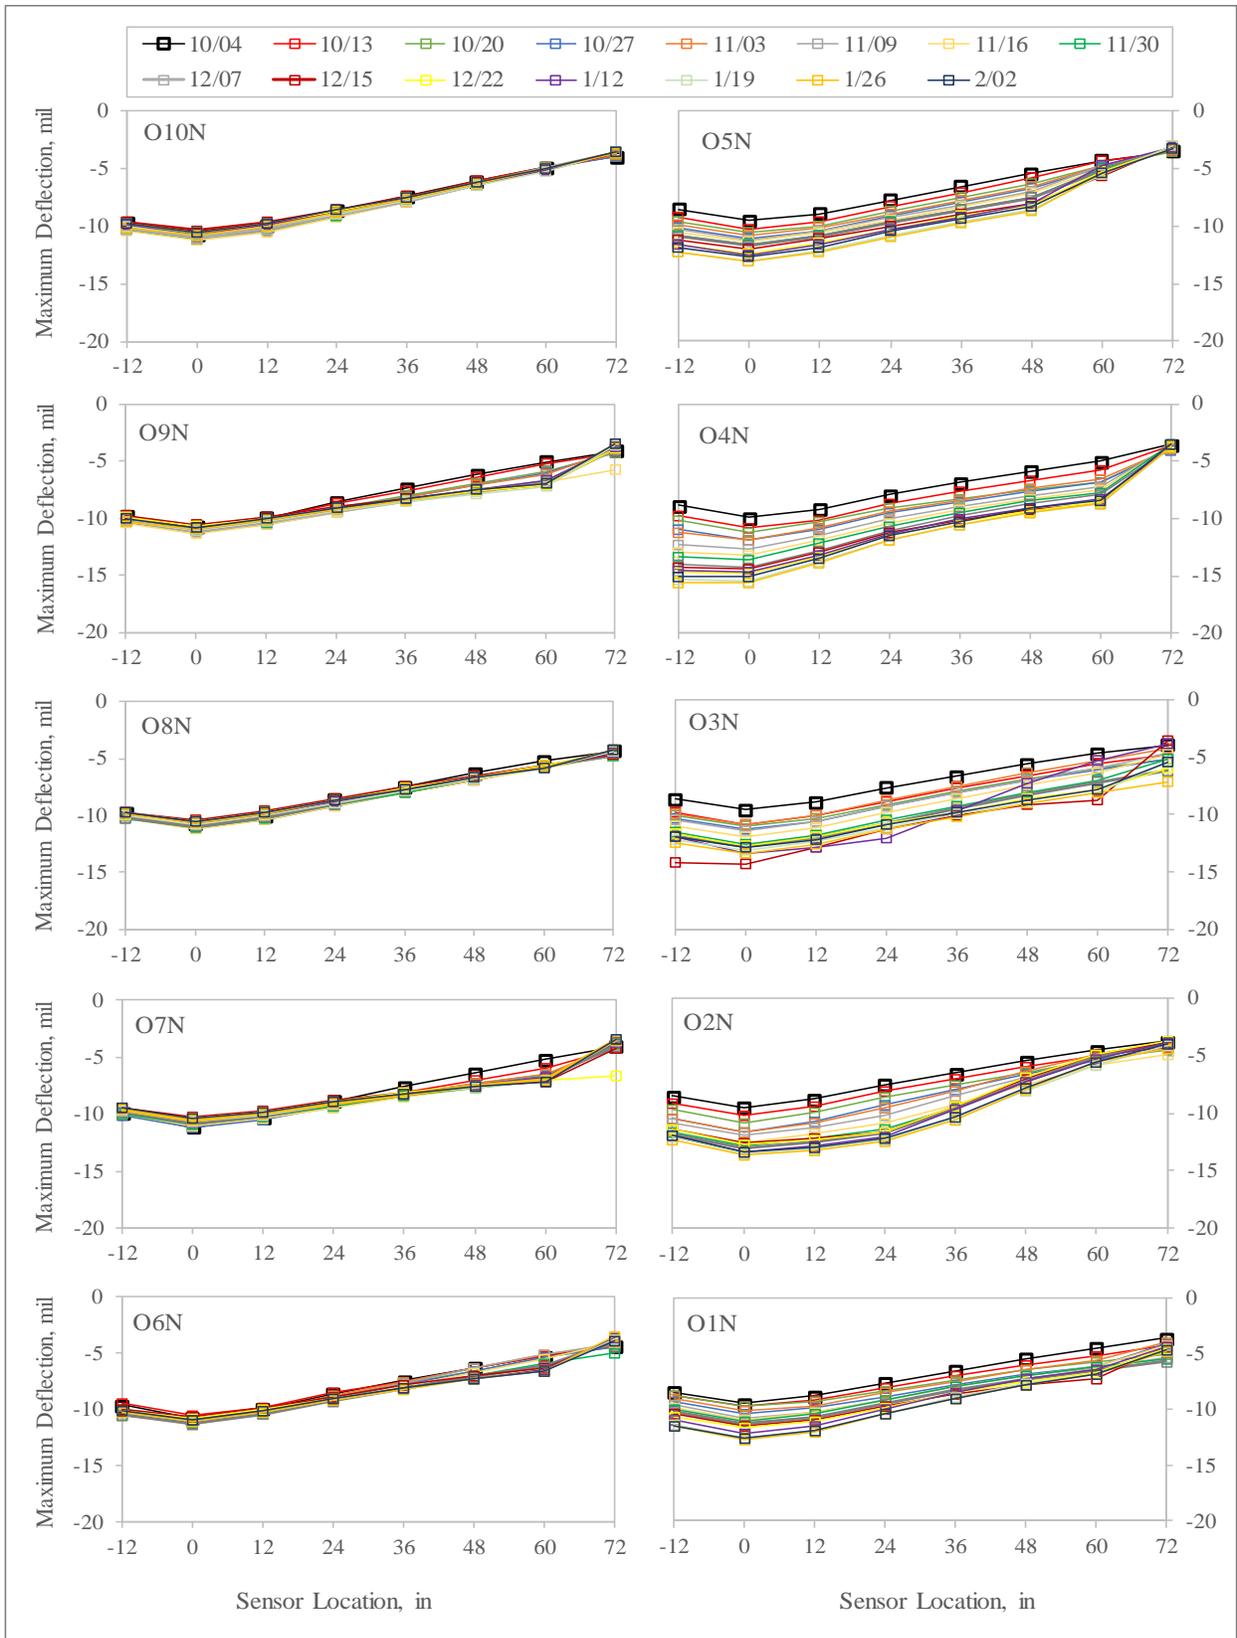
Deflection basins measured at the slab centers corresponding to 36,000 pounds are plotted in Figures 41 and 42 for the north and south test item, respectively. On the north test item (see Figure 41), notable changes in the deflection basin over the course of trafficking were observed in slabs O1N through O5N. In these slabs, deflections gradually increased with respect to the baseline. This indicates that the overall strength of the pavement system deteriorated with

traffic. On slabs O1N and O3N, an increase in deflections was noticed at the geophone located 72 inches from the center of the loading plate. This suggests that some of the damage accumulated in deeper layers during the traffic test. In general, no significant variations in the deflection basin were observed for slabs O6N through O10N. However, some changes were recorded by the geophones at 48 and 60 inches in slabs O7N and O9N. This indicates the possibility of isolated damage in supporting layers. As expected, the outer slabs O6N through O10N did not exhibit significant deterioration.

Figure 41. Slab Center Deflection Basins, North Test Item

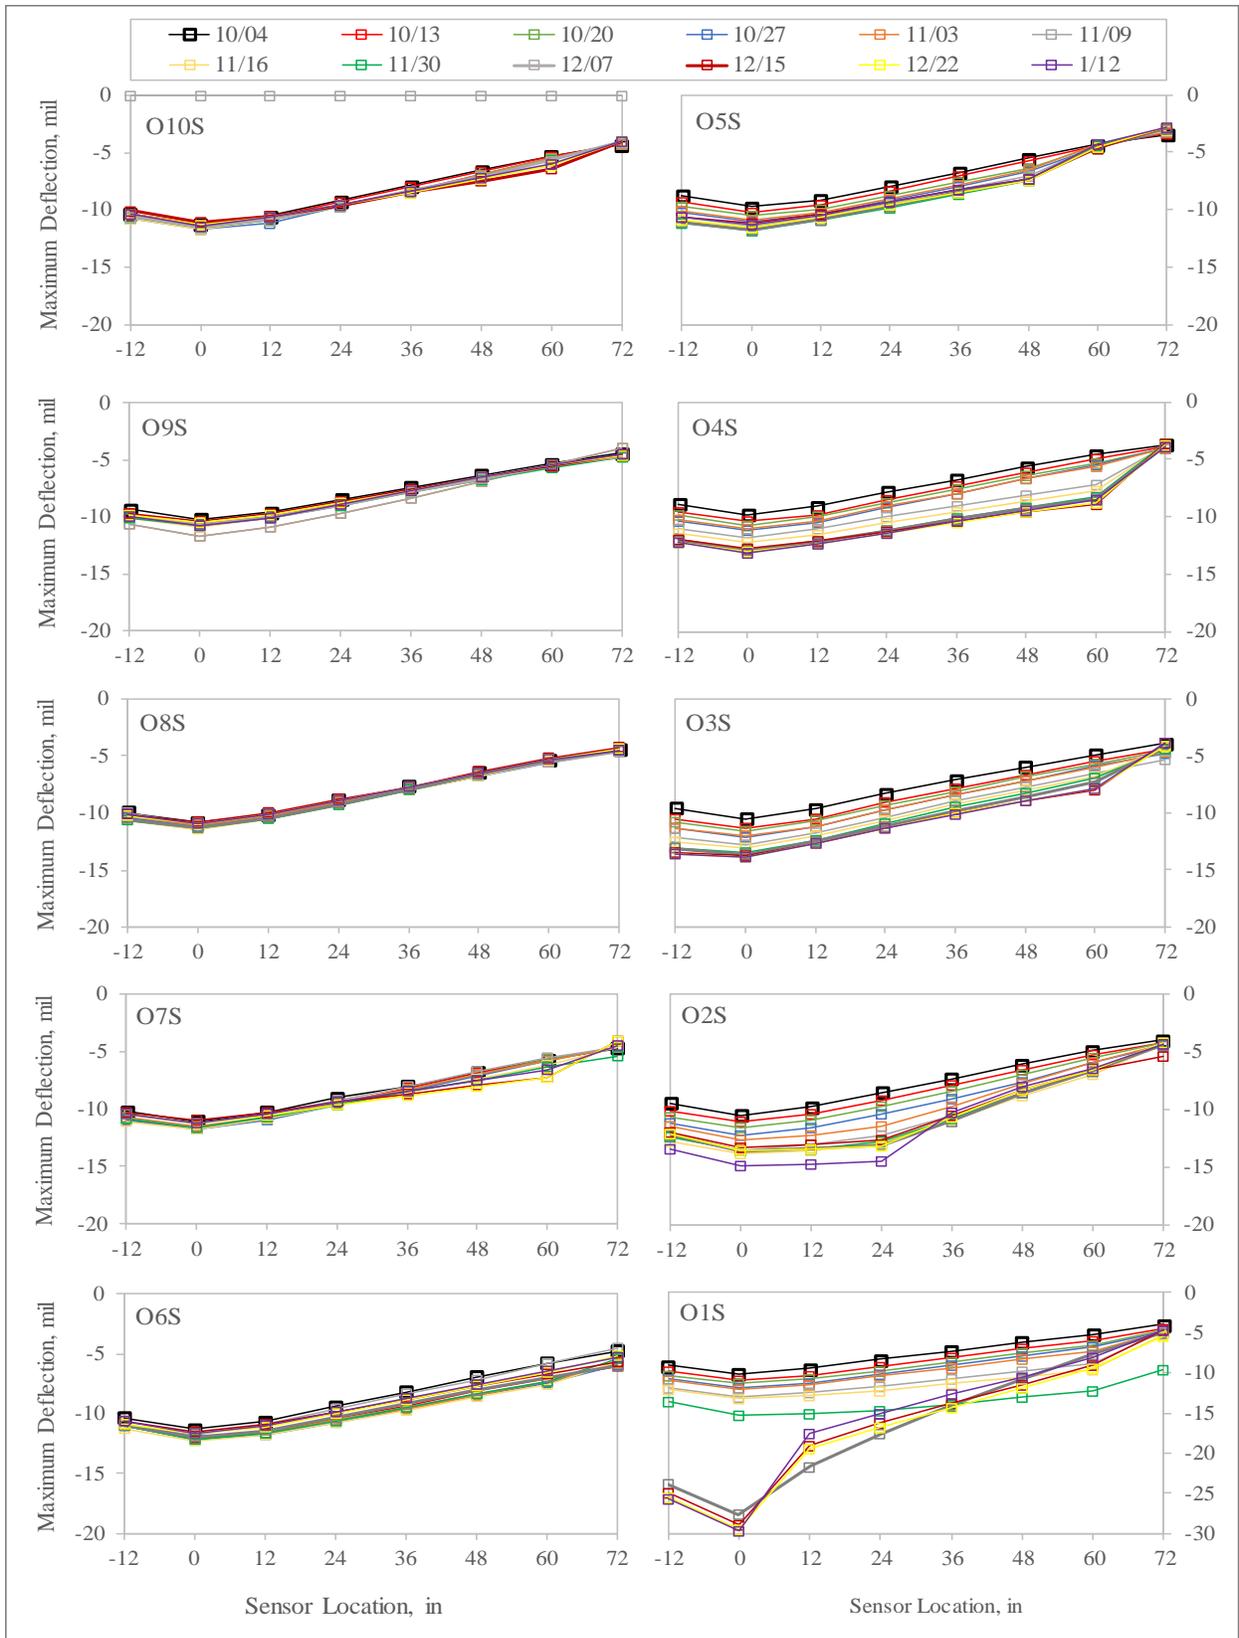
Figure 42 shows the deflection basins for slabs on the south test item. Again, no significant variation in deflection basins were observed on the outer slabs (i.e., O6S through O10S) compared to those in the inner lane (i.e., O1S through O5S) which received most of the traffic. Deflection on inner slabs increased over the course of traffic. Slab O5S presented the least variation in the deflection basin over time, and showed the least amount of distresses as reflected by the crack density parameter (see Table 9). Conversely, slab O1S showed the most significant changes in the deflection basin starting on 11/30/2017. Such changes reflected the severe deterioration underwent by slab O1S within the same period: occurrence of a diagonal crack across the slab center and subsequent shattering after 11/30/2017 (see distress survey log in Appendix C).

Figure 42. Slab Center Deflection Basins, South Test Item

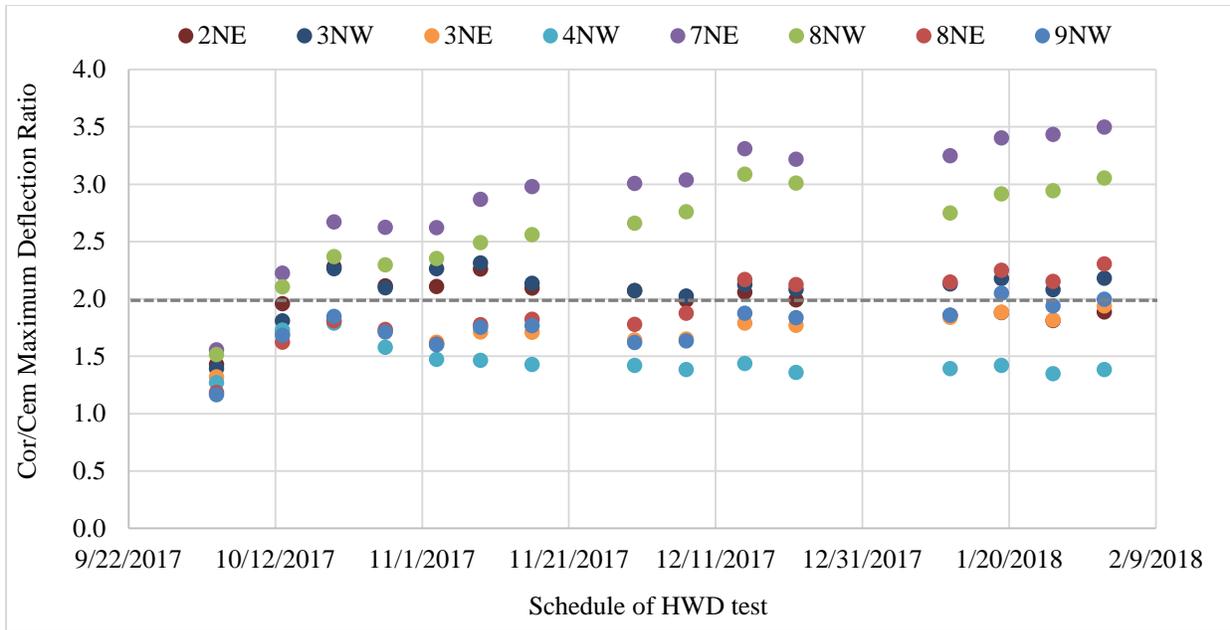
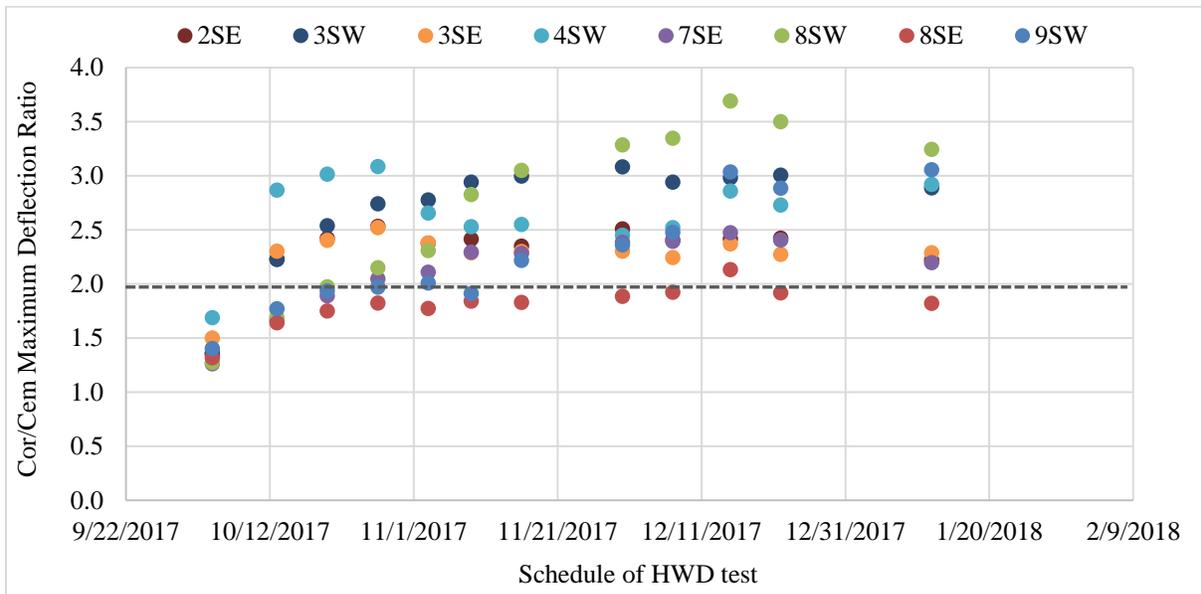
Figure 50(a) and (b) show the variation of the corner-to-center deflection ratio over time in the north and south test items, respectively. During the baseline HWD testing, the corner-to-center deflection ratio ranged from 1.1 to 1.7. After the traffic test started on 10/10/2017, the corner-to-center deflection ratio showed an increase. The slabs along the outer lane (i.e.; slabs O6N through O10N) in the north test item consistently showed an increasing trend of the ratio. Along the inner lane (i.e., slabs O1N through O5N) the trend was inconsistent. As seen in Figure 50(a), corners 7NE and 8NW experienced the most significant increase of corner-to-center deflection ratio in the north test item. This can be due to loss of underlying support. Upon completion of the traffic test, a terminal ratio over 2.0 was observed in the following corners: 3NW, 7NE, 8NW, and 8NE. The assessment of corner deterioration in these locations will be complemented with the void analysis presented in the following section.

On the south test item, the terminal corner-to-center deflection ratio in all corners evaluated, except 8SE were over 2.0 as seen in Figure 62(b). Furthermore, in corners 3SW, 4SW, 8SW, and 9SW slab corner deflections as high as 3 times slab center deflections were measured at some point during the traffic test. This is evidence that loss of support from underlying layers in the south test item was more significant than the north side. Also, this is consistent with the deterioration observed in the south test item where corner breaks dominated the distress pattern. Moreover, this reinforces the speculation that the underlying support conditions in the south test item may have induced the unexpected high rate of deterioration and premature failure relative to the north test item. The void analysis addressed in the next section will complement the evaluation of corner deterioration in the south test item.

Figure 50. Corner-to-Center Deflection Ratio: (a) North Test Item, (b) South Test Item

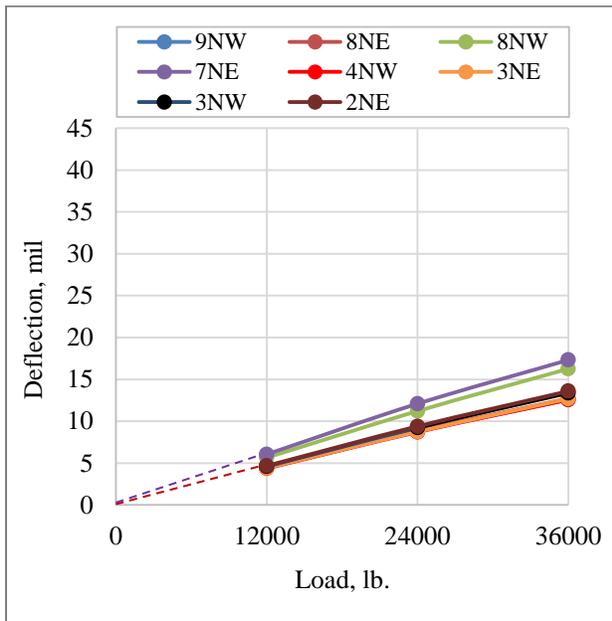
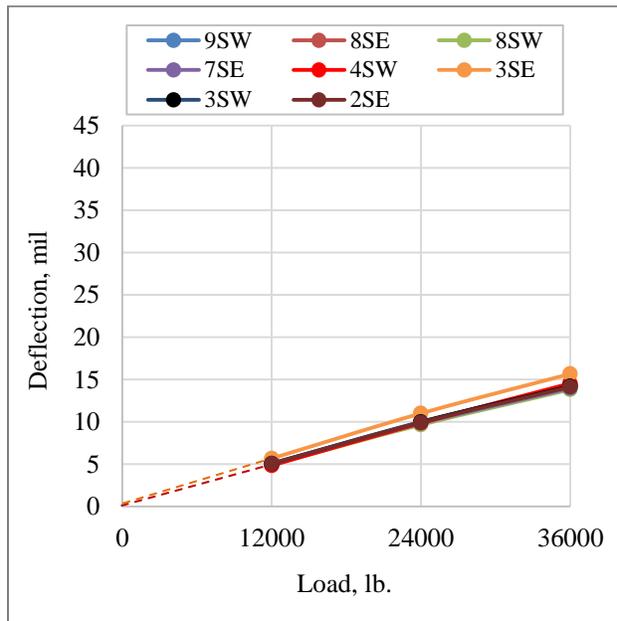
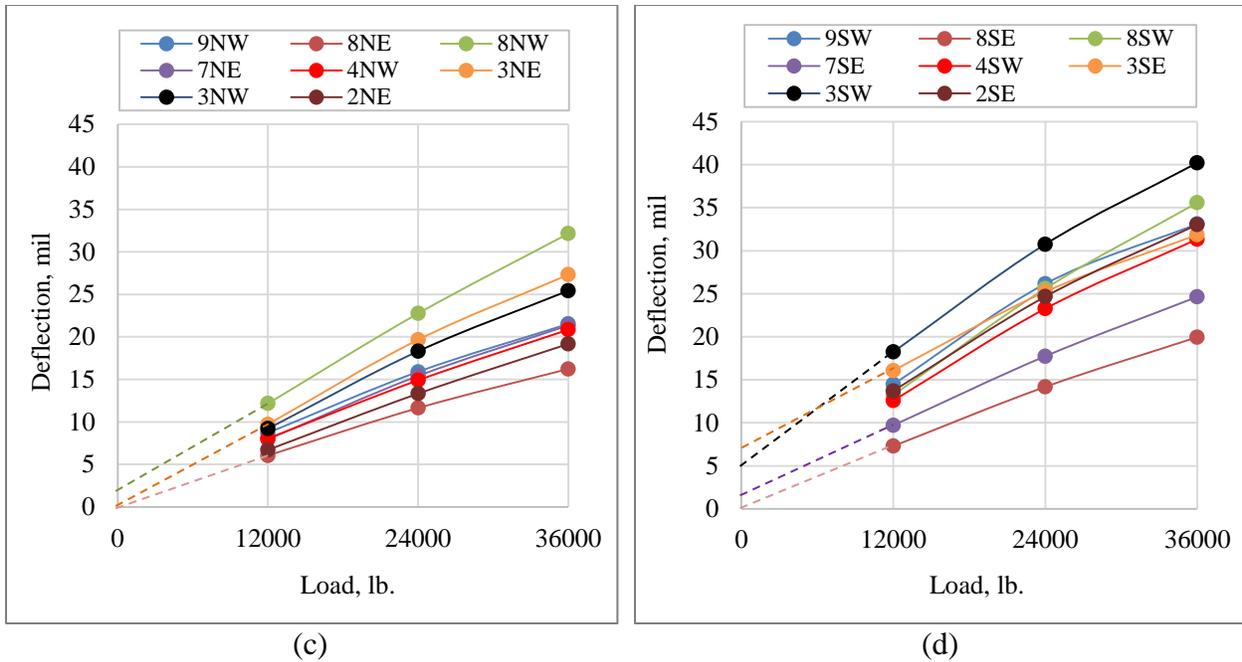
enough, a void can be ruled out. Figure 51(a) and (b) show the maximum corner deflections from the baseline HWD testing on both the north and south test item. In both test items, intercepts close to zero were observed. This indicates that, prior to trafficking, there were no voids underneath the slab corners evaluated.

Figure 51(c) and (d) show the maximum corner deflections from the last HWD testing conducted on each test item. The traffic test on the north and south test item was terminated after 37,290 and 29,370 vehicle passes, respectively. Slab corners 3NW, 7NE, 8NW, and 8NE all had terminal corner-to-center deflection ratios greater than 2.0. Based on the observed intercepts, only corner 8NW exhibited a slight potential for void existence. However, no corner break was reported at this location. The presence of voids underneath all other corners evaluated in the north test item can be disregarded. Moreover, only one corner break was observed in the north test item which is consistent with the absence of evidence supporting the existence of voids.

On the south test item, slab corner 8SE was the only corner for which HWD analysis did not show evidence of a void. This is consistent with the analysis of corner-to-center deflection ratio where 8SE was the only corner with terminal corner-to-deflection ratio under 2.0. Intercepts for the remaining slab corners deviated from zero and indicated small to medium voids. In the case of corner 7SE and 8SW, there was only a slight potential for the existence of voids. In general, the presence of voids in the south test item is consistent with corner breaks dominating the distress pattern, and with the premature deterioration and failure relative to the north side. This also supports the supposition that there were deficient support conditions for some of the slabs in the south test item.

Figure 51. Void Detection on Slab Corners: (a) Baseline-North, (b) Baseline-South, (c) Terminal-North, (d) Terminal-South

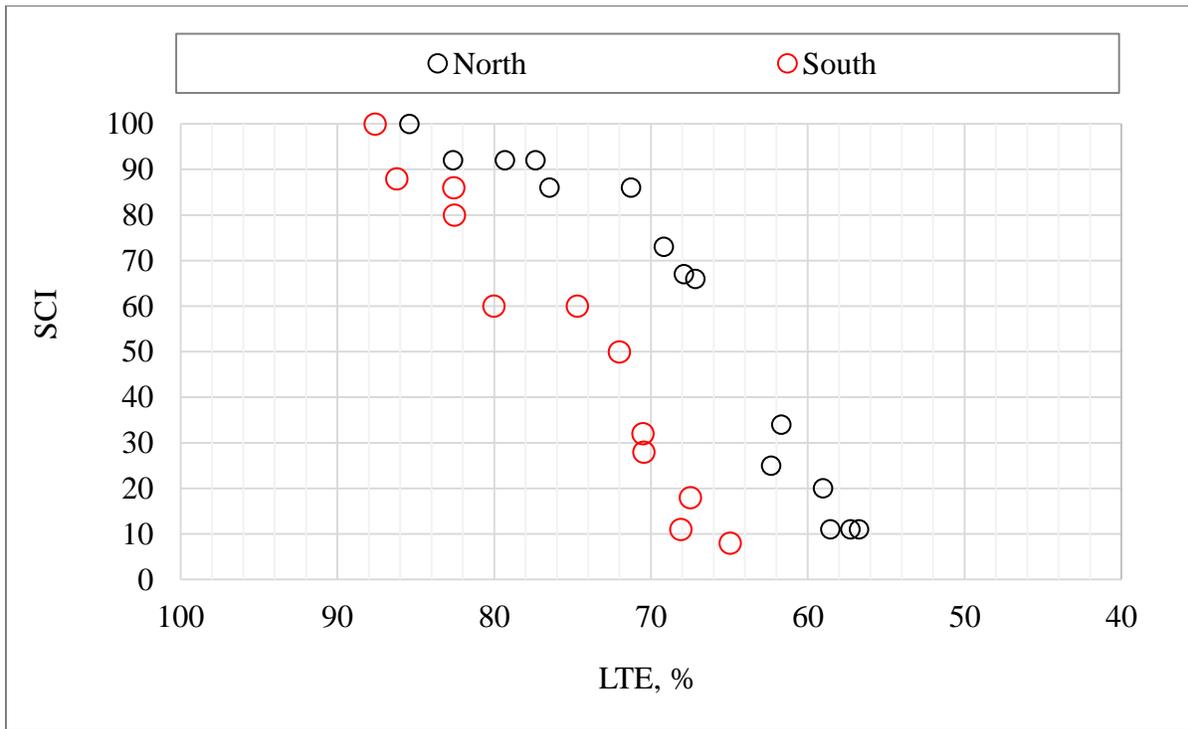
Figure 62. LTE Degradation due to SCI Rating

- The joint deterioration was evaluated in terms of LTE. A good correlation was observed between LTE and SCI. Considering both the north and south test item, an LTE ranging between 55% and 65% was attained when the SCI dropped to about 10.

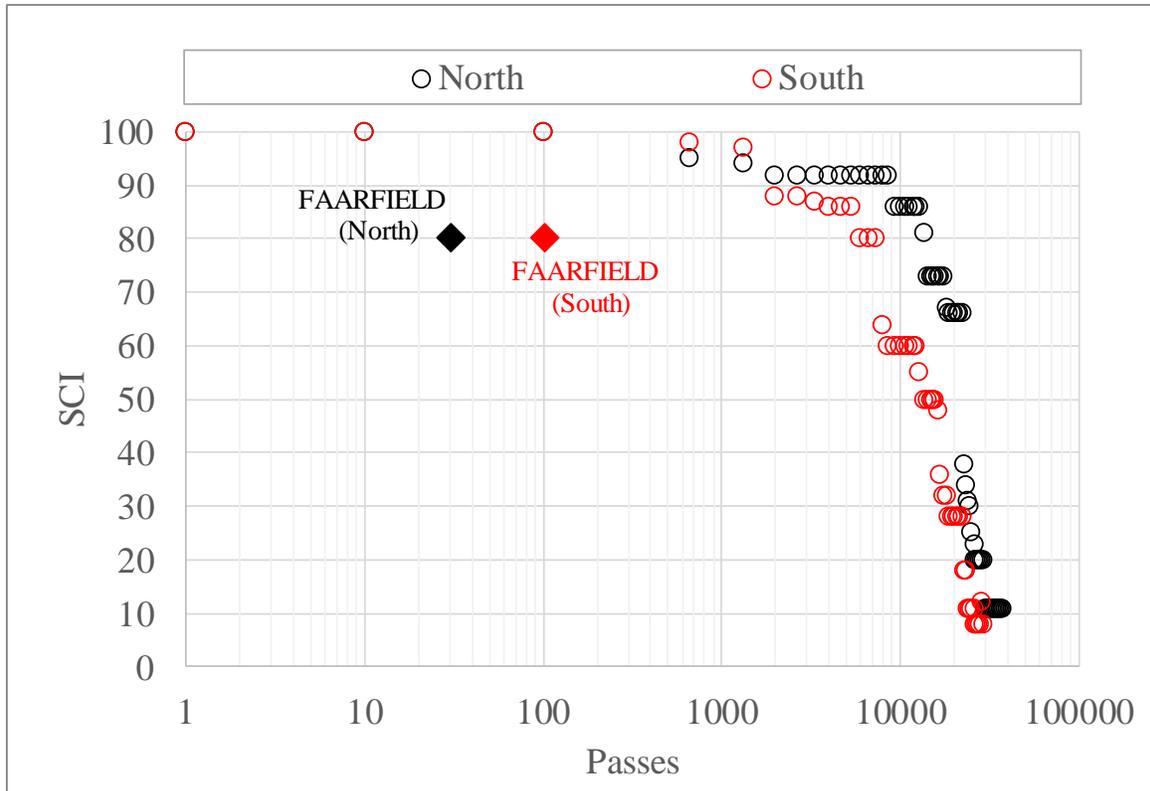
Discrepancies between the FAARFIELD failure prediction and the actual overlay deterioration during the traffic test can be observed in Figure 63. The predicted number of passes to failure were 31 and 103 for the north and south test item, respectively. The overlay actually required 13530 and 5940 passes to achieve a SCI value around 80 in the north and south test item, respectively. In this section, the performance curve is evaluated using the newly generated full-scale test data from the CC8 Phase II Overlay experiment.

Figure 63. Observed Changes in SCI versus FAARFIELD Failure Prediction

- Discrepancies between the FAARFIELD failure prediction and the actual overlay deterioration during the traffic test were observed. The predicted number of passes to failure were 31 and 103 for the north and south test item, respectively. The overlay actually required 13530 and 5940 passes to achieve a SCI value around 80 in the north and south test item, respectively.

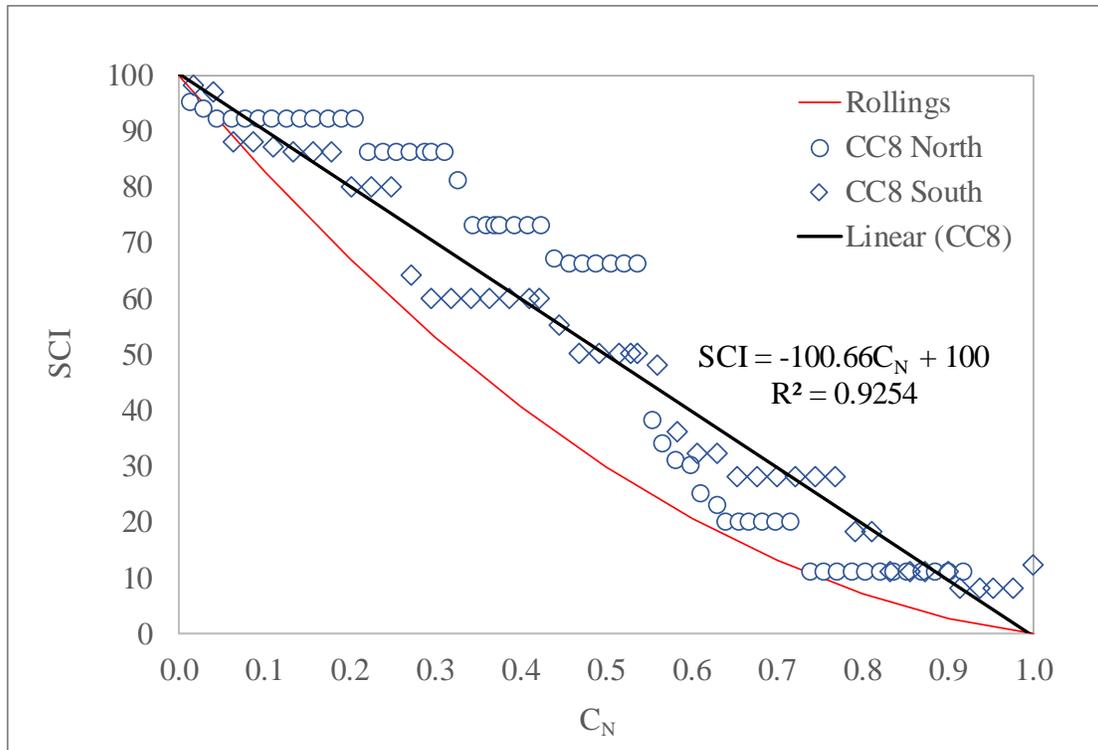
Interpreting the $C_N - SCI$ relationship as a measure of the rate of structural deterioration with traffic, the concave shape of the curve in Figure 78 indicates slowing deterioration rate. In Figure 79, the data generated in the overlay experiments conducted during CC4 show a linear deterioration trend when compared to Rollings model, indicating a relatively constant rate of deterioration (3). The newly generated full-scale test data from the CC8 Phase II Overlay experiment verified the linear deterioration trend reported in CC4. In Figure 80, the CC8 linear relationship is compared to Rollings model. Although the north and south test item deteriorated at different rates, when combining both datasets the overall rate of deterioration was found to be relatively constant. Furthermore, when comparing the CC4 to CC8 linear relationship, both show similar slopes.

Figure 67. Relationship Between Normalized Coverage and SCI Based on CC8 Overlay Test Data

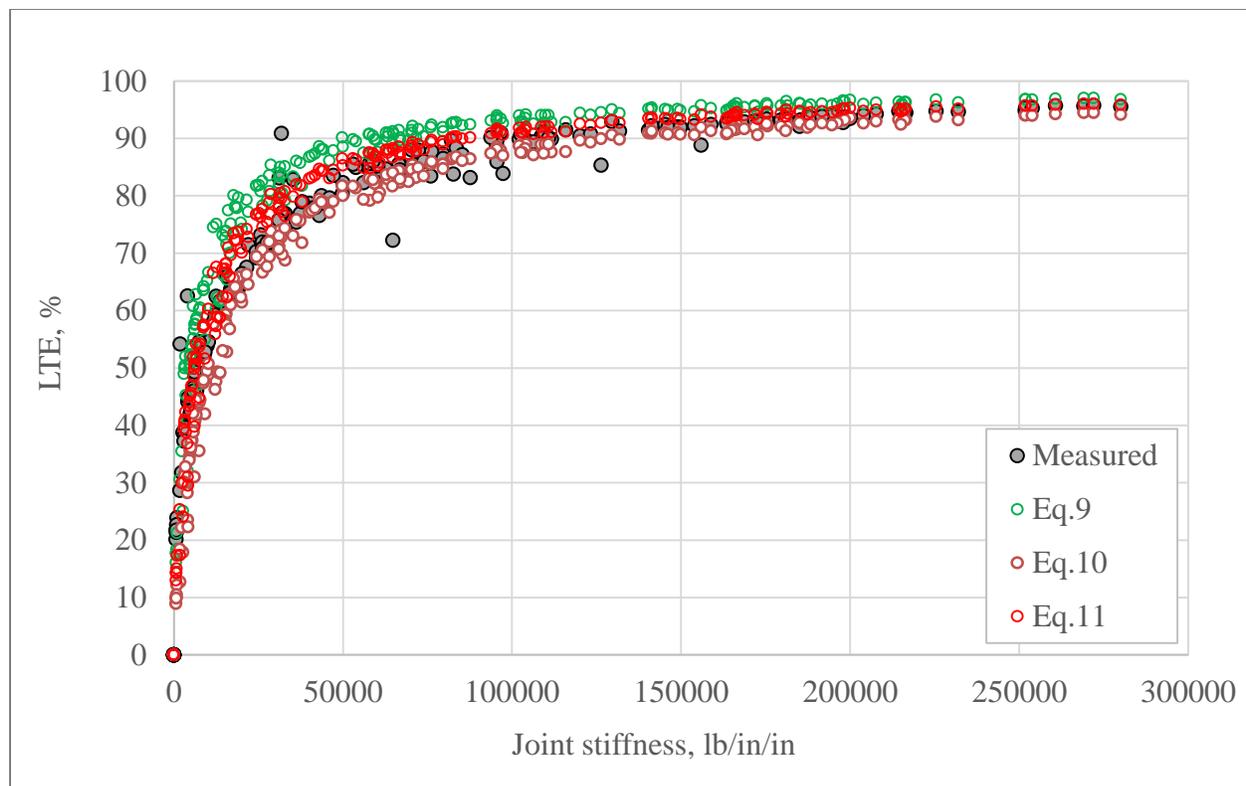
Once the joint stiffness was calculated using the equations shown above, the correlations between LTE and joint stiffness were plotted. Considering the stiffness obtained with Equation 3 as the measured value, in Figure 69 the predicted joint stiffness calculated using Equations 4, 5 and 6 are compared to the measured stiffness. In general, both measured and regression model-based joint stiffness (i.e., Eq. 4, 5 and 6) followed similar trends as function of LTE .

Figure 69. Joint Stiffness as Function of LTE
