DOT/FAA/TC-12/6

Development of a Firefighting Agent Application Test Protocol for Aircraft Fuselage Composites, Phase I—Carbon Fiber

June 2012

Final Report

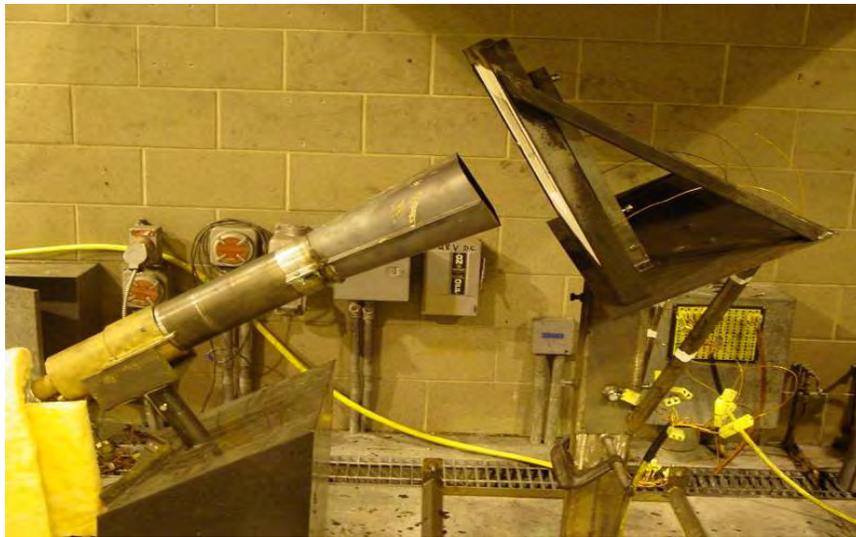
The NextGen burner is an updated version of the Park Oil Burner [7]. Average temperatures generated by the NextGen burner are just over 1800°F (990°C). For these tests, it was mounted on a small platform at a 45° angle as shown in figure 1, just as it is configured for thermo-acoustic insulation tests.

Figure 1. Kerosene-Fired FAA NextGen Burner and Sample Frame

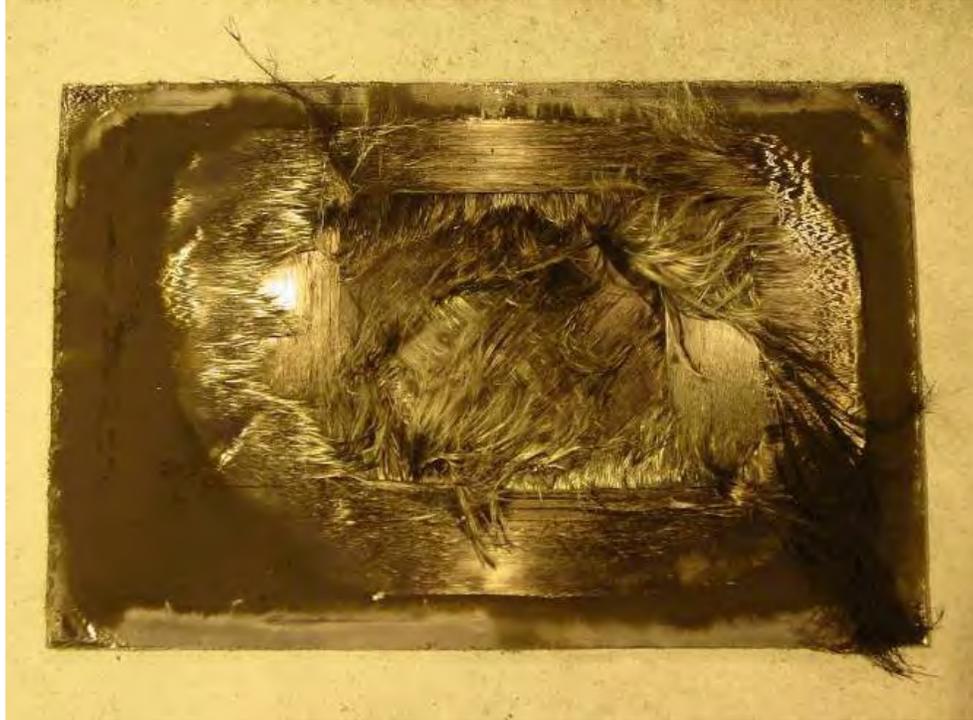
When comparing each sample's initial weight to the postexposure weight, it is clear that the duration of exposure has a direct effect on the amount of remaining resin and fiber. On average, one minute exposures left 83.9% of the initial weight and 10-minute exposures left 68.7% of the initial weight. Longer exposures, particularly 10 minutes, regularly caused severe damage to the front of the sample, localized to the center in a general outline of the burner cone. In these exposures, a rough hole was made in the outer plies. The depth of penetration into each 10-minute sample varied slightly but in most cases, as in figure 6, taken from test 5, the $\pm 45^\circ$ plies were visible. The edges of the rough hole had jagged, soft-fiber ends and there were fibers loosely hanging from the sample.

Figure 6. Postexposure Damage, 10-Minute Exposure

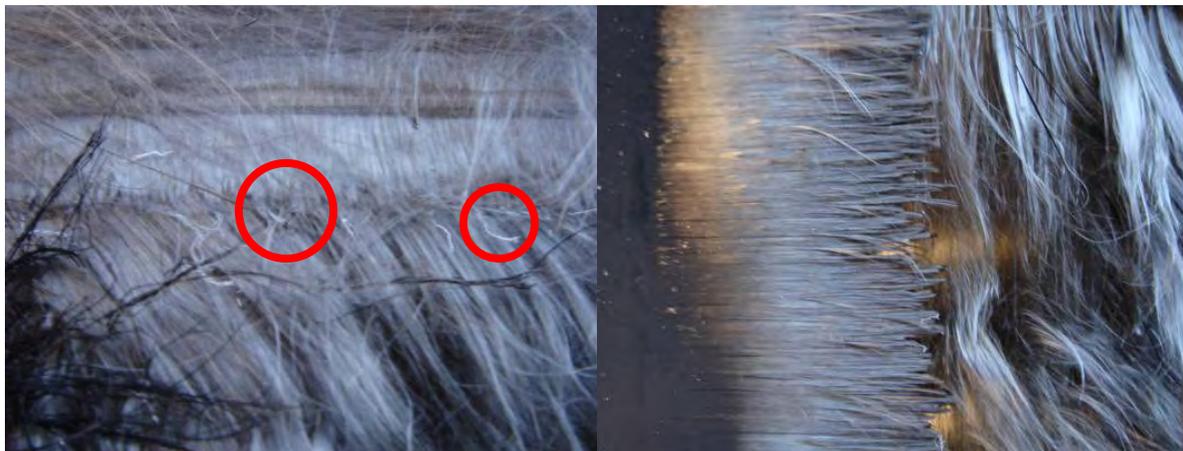
On the outer plies, soft bunches of hair-like carbon fibers, called fiber clusters, hung from the sample edges. The loose fiber clusters were released during the longer exposure, which accounts for some of the missing fibers and weight. Notably, some carbon fibers had light-gray colored ends, especially in tests 13, 14, 15, and 21, around the border of the hole (see figure 7).

Figure 7. Close-Up of Gray, Jagged Fiber Ends From Test 15

Although a more detailed assessment of the gray ends was not part of this assessment, Quintiere [2] documented that oxidation will occur at sufficiently high temperatures. Gandhi and Lyon [8] found that fire significantly reduced fiber size, in part due to oxidation. Gandhi further documented that oxidation at temperatures above 1640°F (900°C) in an oxygen-rich

environment will completely consume carbon fibers. Considering the NextGen burner can reach 1800°F (990°C) or more, it is possible that these gray fiber ends were oxidized carbon fibers and the jagged fibers resulted from fiber ends that had been oxidized and reduced to dust.

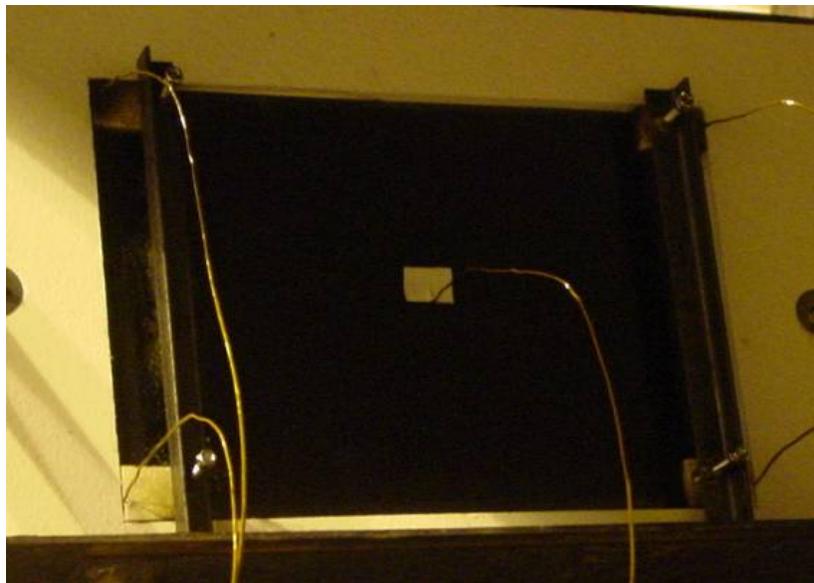
Initially, in tests 1-8 and 10, TCs were set under the Kaowool pad with the wire leading out between the pad and the border, as shown in figure 14. A schematic of the initial corner TC placement in figure 15 shows the Kaowool in blue, the composite sample in black, and the TC in red.

Figure 14. Initial Corner TC Placement

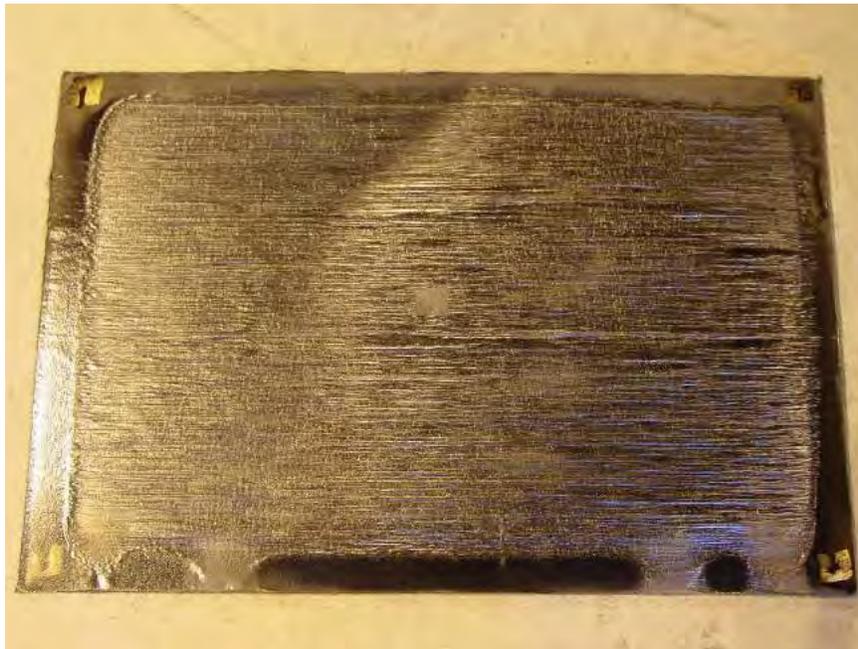
A clear border of less damage around the entire sample, with hardened bubbles of resin char in some areas, was obvious during the postexposure inspection, as shown in figures 20 and 21. In test 17, the sample buckled at the center of the top edge, cracking the front Kaowool board after 41 seconds of fire exposure. The sample started to smoke at 16 seconds, with heavy smoke at 20 seconds. At approximately 27 seconds, the amount of smoke reduced. This reduction in smoke was more obvious just prior to the mechanical failure. Once the failure occurred, a surge of heavy smoke came from the top edge. Ignition of the heavy smoke occurred at 42 seconds.

Figure 21. Back of Sample From Test 1B Postexposure

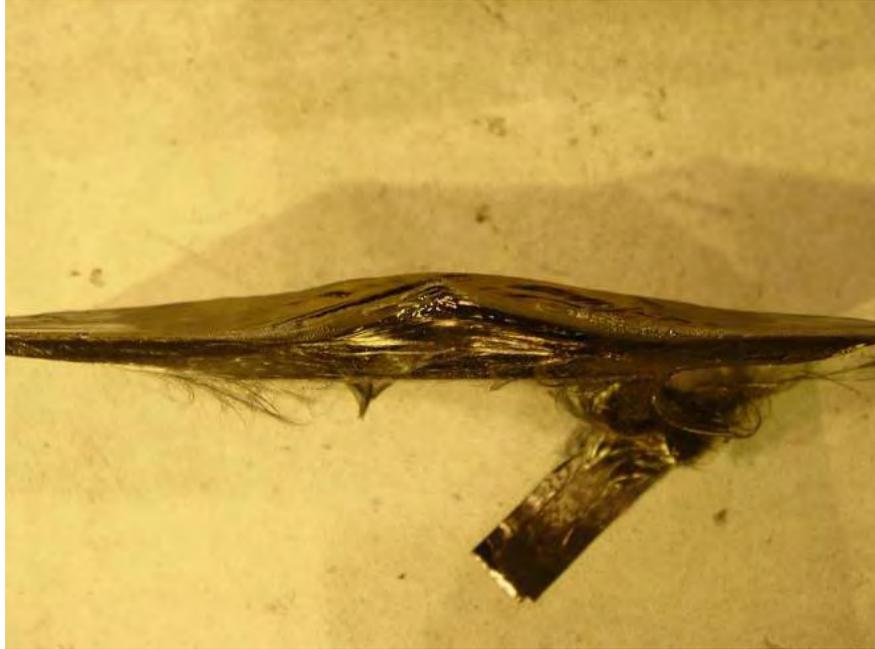
During the other tests where a sudden failure of the sample occurred, the sudden burst of fire from the back was the only indication of a mechanical failure. A postexposure inspection confirmed that the sample buckled. The mechanical failure from test 4 is shown in figure 22.

Figure 22. Buckled Sample From Test 4

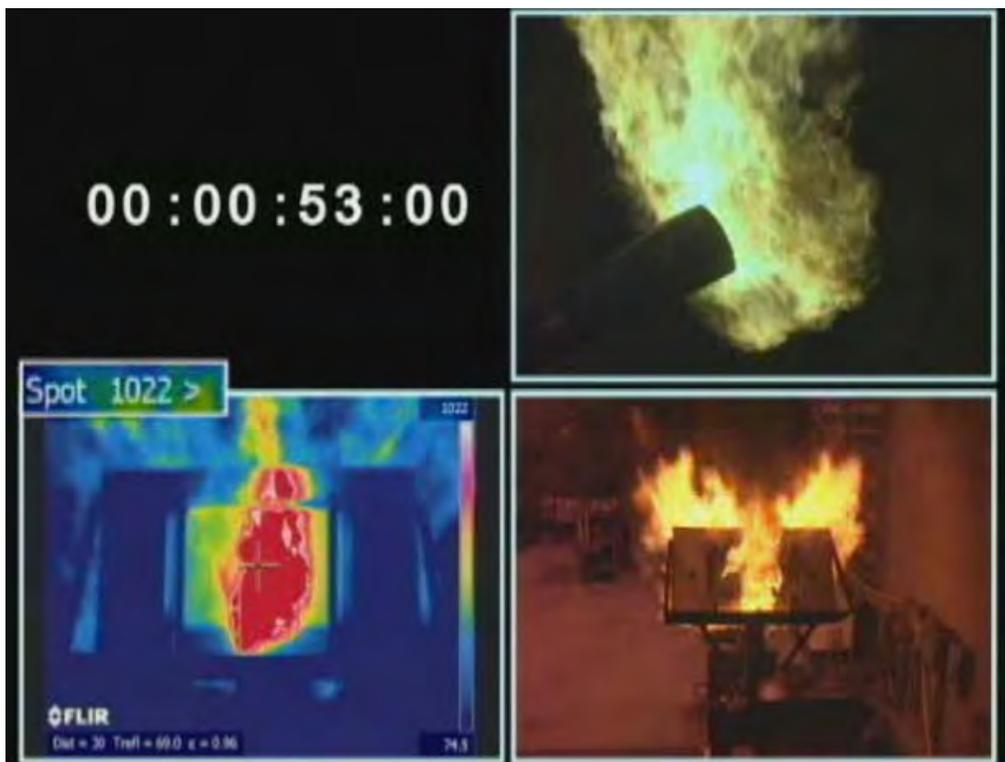
As discussed in section 2.5, there were clear instances when the heavy smoke contacted with an ignition source. In tests 4 and 21, a mechanical failure of the sample led to smoke ignition, which led to complete fire involvement of the back side. Figure 23 shows the amount of backside flame for test 4. Figure 24 shows backside flame during test 21. Test 4 suffered the mechanical failure at 35 seconds, as indicated by a burst of thick smoke and a color change in the IR image. Full involvement of the back occurred at 53 seconds. For test 21, the results were nearly identical: failure at 23 seconds with full flame involvement at 49 seconds.

Figure 23. Backside Flame Involvement in Test 4

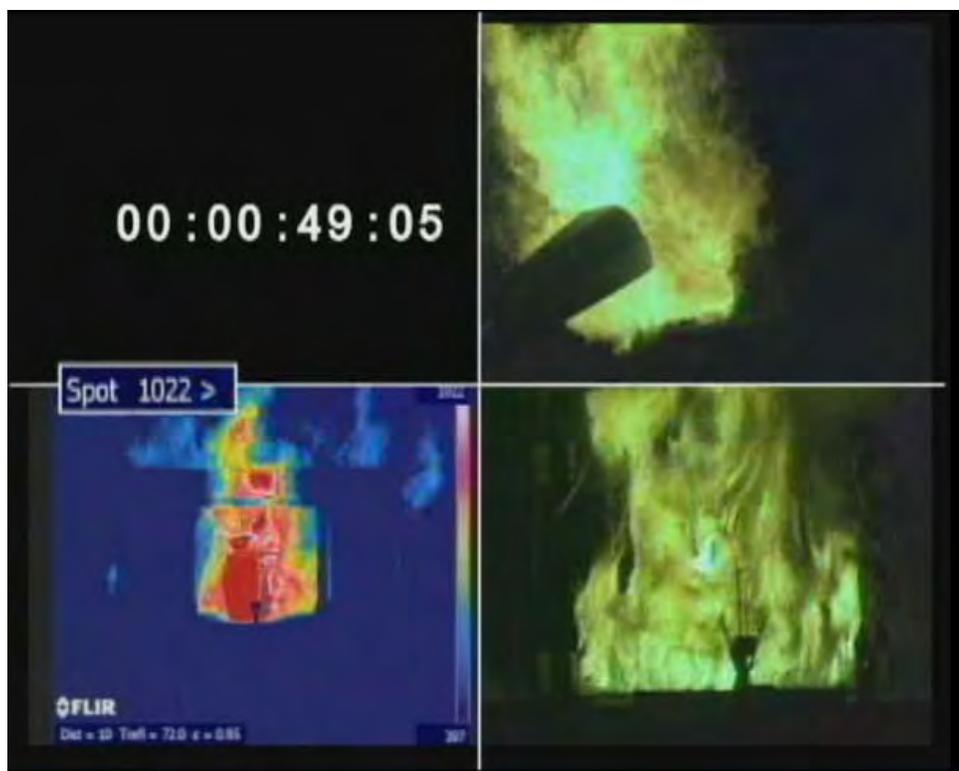
Figure 24. Backside Flame Involvement in Test 21

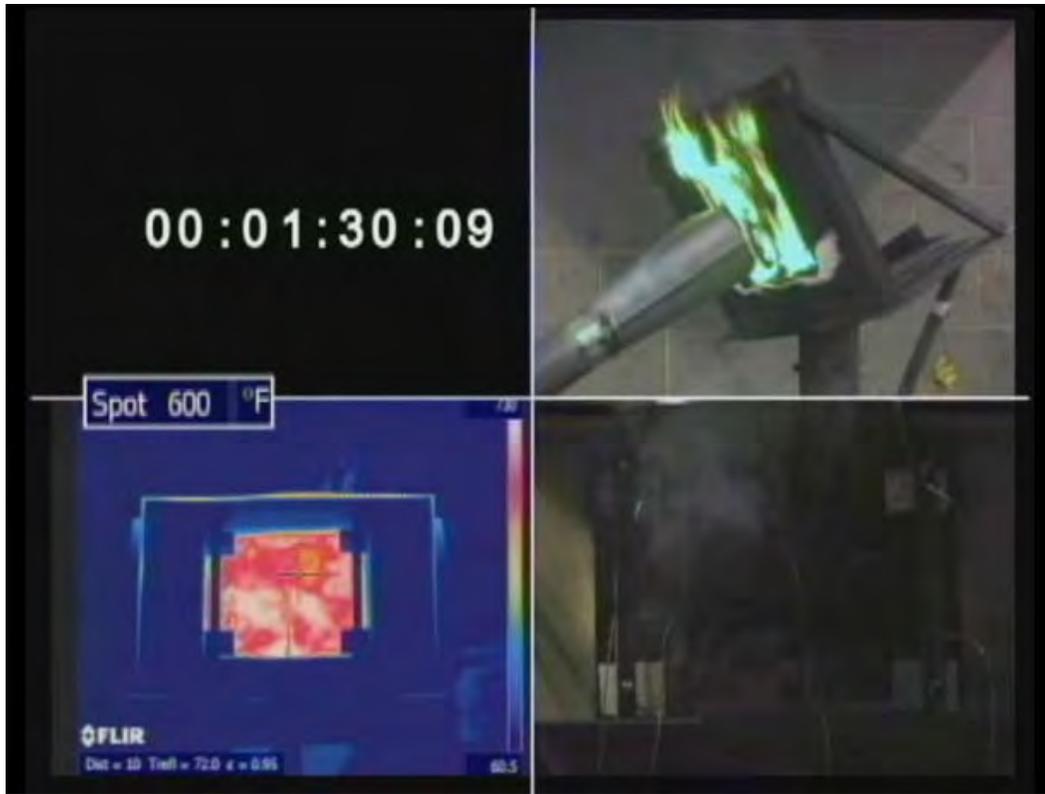
Figure 26. Postexposure Flaming Combustion, Test 16

In some instances, as in the 1-second flame duration from test 13, the flames were very small, and scattered about the front, or the front edges. In other instances, flickers of flame were observed inside the sample, through gaps in the delaminated outer fiber plies, as in tests 6 and 16. Tests 16 through 18 were 1-minute tests in which, after removal of the burner, the entire front was enveloped by flame, as shown in figure 26.

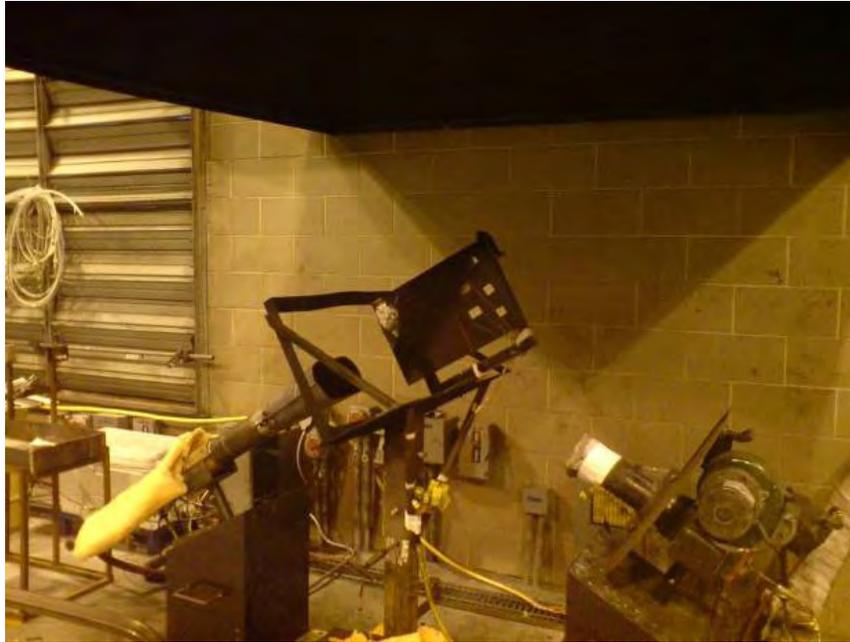
Figure 27. Sample Orientation for Test 9

Test 9 was conducted to determine if immersing an edge of the sample into the burner flame, on a downward angle, would inflict a more severe postexposure flaming or even flame propagation. The sample was fixed on the same frame used for the primary configuration, but the sample was held vertically with the 12-inch edge facing into the burner flame. Figure 27 shows the sample orientation.

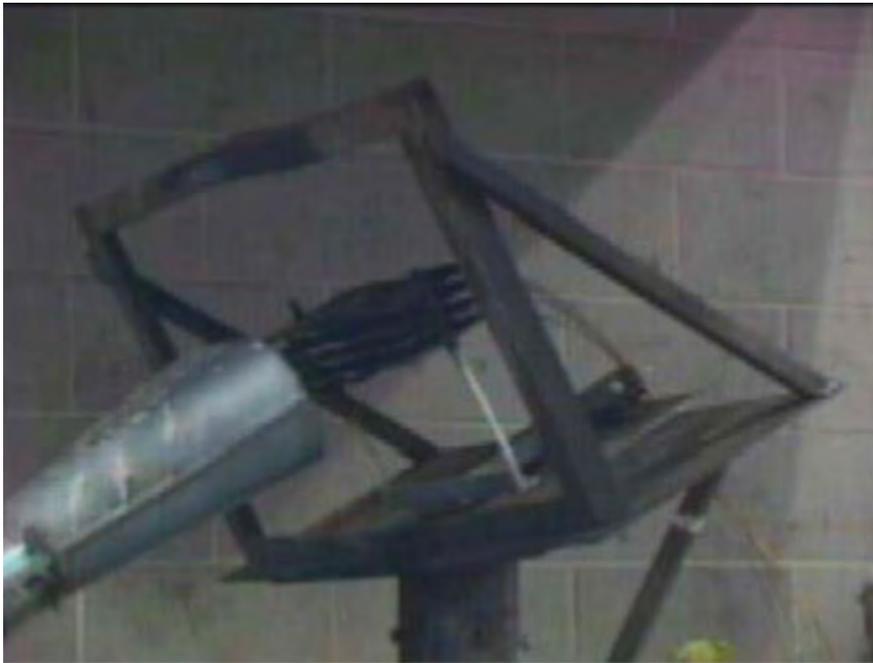
Figure 29. Sample Orientation for Tests 22 and 23

The samples used in tests 22 and 23 were cut into four equal pieces that were layered with 3/4-inch (76.2-mm) gaps between each piece. Figure 29 shows the sample orientation after test 23. These tests were conducted to determine how radiant heating between the layers changed the postexposure conditions, particularly the amount and severity of any smoldering.
