Reflective Cracking Testing Notes

Project: Reflective Cracking Indoor Phase IV

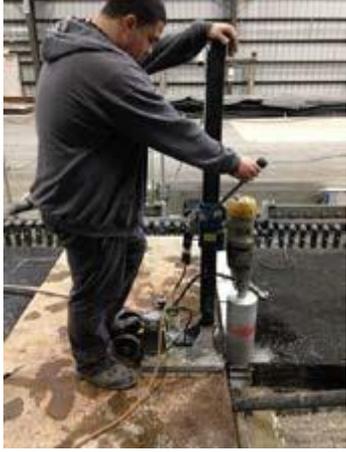
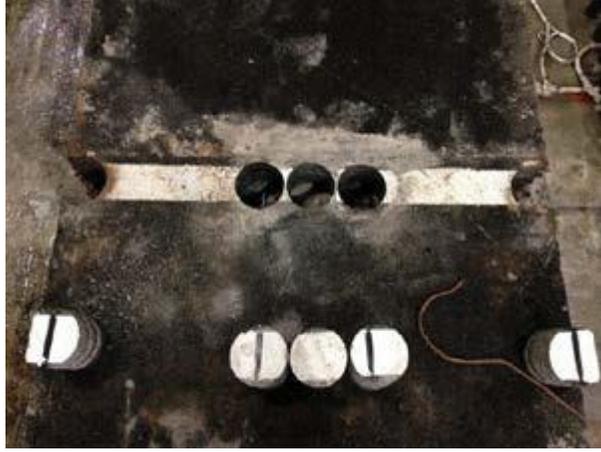
Figure 1. Coring the Test Section.

An SRA technician obtained (5) core samples (6” in diameter) from each Phase IV test section along the joint at the direction of a Gemini engineer. For each test section, (2) cores were obtained along each edge and (3) were obtained at the middle. A total of (10) samples were obtained between both test sections. A portable core drill with a 6 inch I.D. core bit was used to drill the cores. A shop vacuum was used to remove excess water during coring and clean-out the core holes upon completion, as shown in Figure 1,
