Reflective Cracking Daily Testing Notes

Project: Reflective Cracking Indoor Phase 2

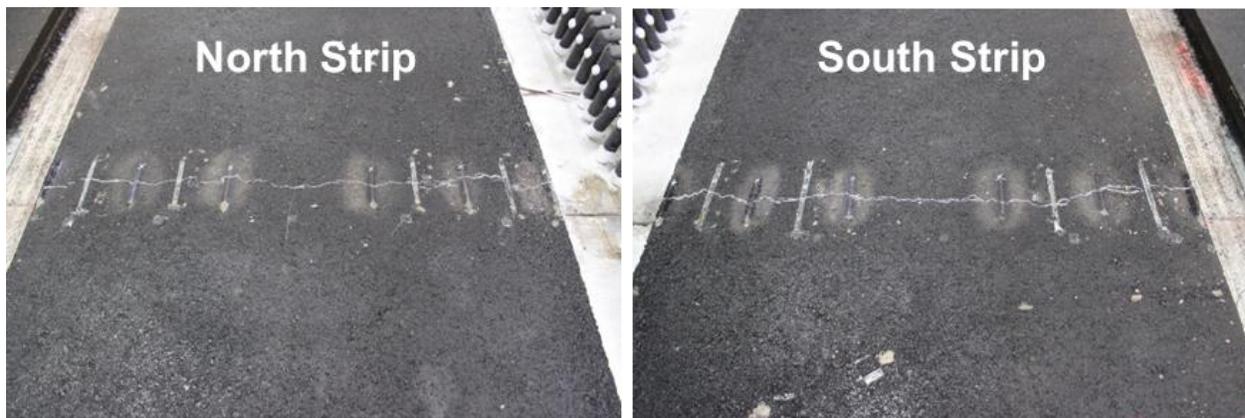
The full-scale test started on January 24, 2013. No mechanical issues were found on the rig. In addition, the asphalt-concrete interface temperature was constantly under 30°F. By the end of February, multiple cracks were through instrumentation, Figure 1.

Figure 1. Multiple Cracks detected through Instrumentation.
